LANDSLIDE ASSESSMENT REPORT

Lot 2, Rada Rd, Kettering

September 2024

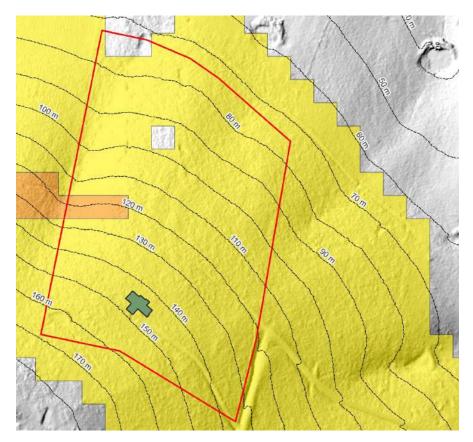
The proposed development (dwelling and driveway cutting) at Lot 2 Rada Road, Kettering, are in a Low Landslide Hazard Band overlay (Figure 1). According to Mineral Resources Tasmania (MRT), the modelled areas have no known active landslides but are identified as *susceptible* to land sliding. These areas are so classified due to slope angle – in this case *"Remaining areas slopes 11-20 degrees"*.

Figure 1: Proposed development envelope at Lot 2 Rada Road, Kettering with MRT Landslide Hazard overlay (yellow), proposed house (green) and 10 m contours shown.

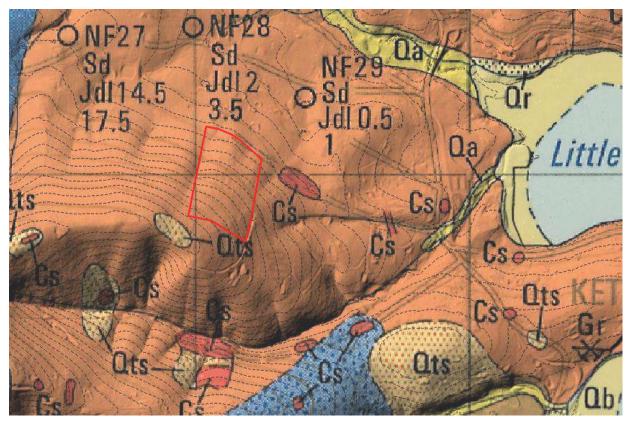
Figure 2: Mapped geology in the environs around Lot 2 Rada Road, Kettering from Mineral Resources Tasmania Geology 1:50,000 Kingborough sheet. Orange areas are mapped as Jurassic dolerite, red = Cretaceous syenite, and yellow with stippled red = Quaternary talus of syenite.

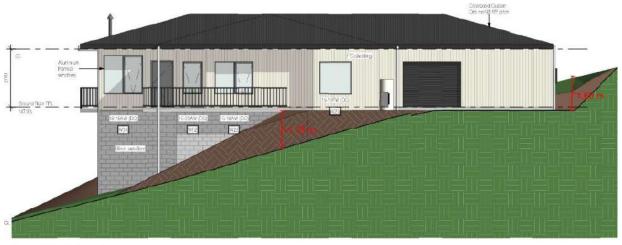
Appendix 1A – Side Elevations & Cut Depths

Preliminary designs (Appendix 1 – house elevations) indicate maximum cut depths of approximately 1.6 m at the rear of the building. Given the shallow depth of unconsolidated soil

For all cuts (< 2.0 m) in <u>unconsolidated</u> rock or soil regolith should be appropriately drained and use a gentle 1V: 2H (vertical: horizontal). Cuts or cut sections into the hard, <u>consolidated</u>, syenite bedrock may utilise steeper batter angles (e.g. 3V: 1H).

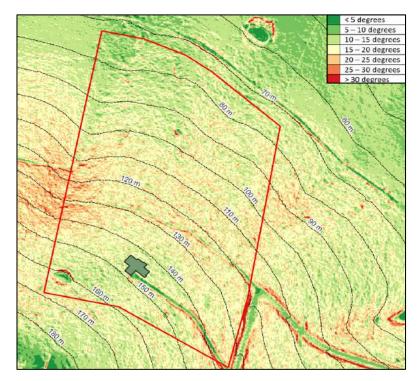
Appendix 4 – Map: Localised slope angle

The development is on slope angles of approximately 10-15°.

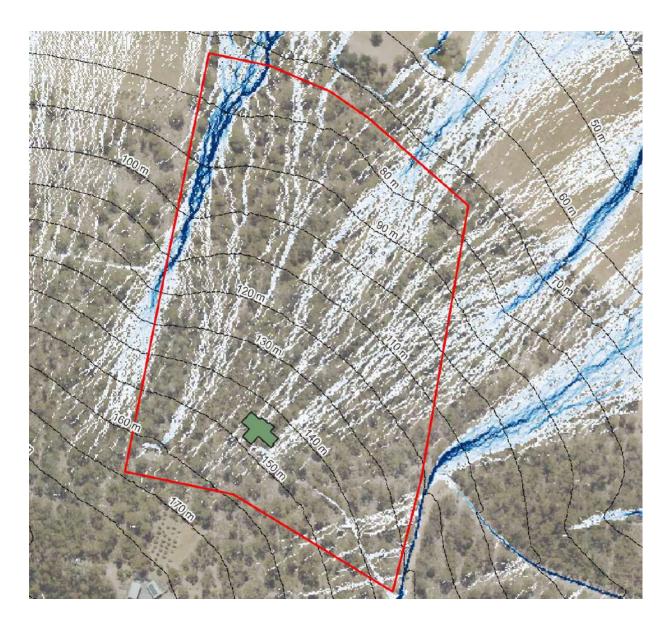
Appendix 5 – Map: Flow Accumulation Model

Surface water flow accumulation model (qualitative) projected over aerial photo of Lot 2, Rada Rd, Kettering. Generated using QGIS with open source 1m Digital Elevation Model (DEM) data (source: elevation.fsdf.org.au) and cadastre shape data (source: maps.thelist.tas.gov.au/listmap).

Note: The uniform slope form means very minor flows of surface water run-on are directed toward to area of development.

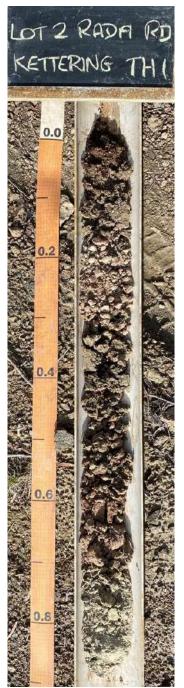
Test Hole 1

Depth (m)	Horizon	Description and field texture grade	USCS Class
0 – 0.2	A1	Greyish brown (10YR 5/2), Gritty Sandy Clay Loam, dry loose consistency, strong fine angular blocky structure, few roots.	SC
0.2 - 0.3	A2	Light brownish grey (10YR 6/2), Clayey Gravel, abundant 5-20mm angular gravels in clayey matrix, single grain, dry hard consistency, slightly dilatant.	GC
0.3 - 0.7	B2	Grey (10YR 6/1), Gritty Sandy Light Clay, very strong medium angular blocky structure, abundant red angular gravels, dry very hard and stiff consistency.	СН
0.7 – 0.85	Cw	Light olive grey (2.5Y 6/2), Gravel with minor fines. <u>Refusal on Syenite bedrock</u>	GC
