Impact of development at 3/22 Corbys Rd, Kettering on nearby trees

-Revised assessment

Jerry Romanski Arborist / Consultant B.Sc (Hons), Ass. Dip. App. Sc.(Hort/Arb)

12 November 2024

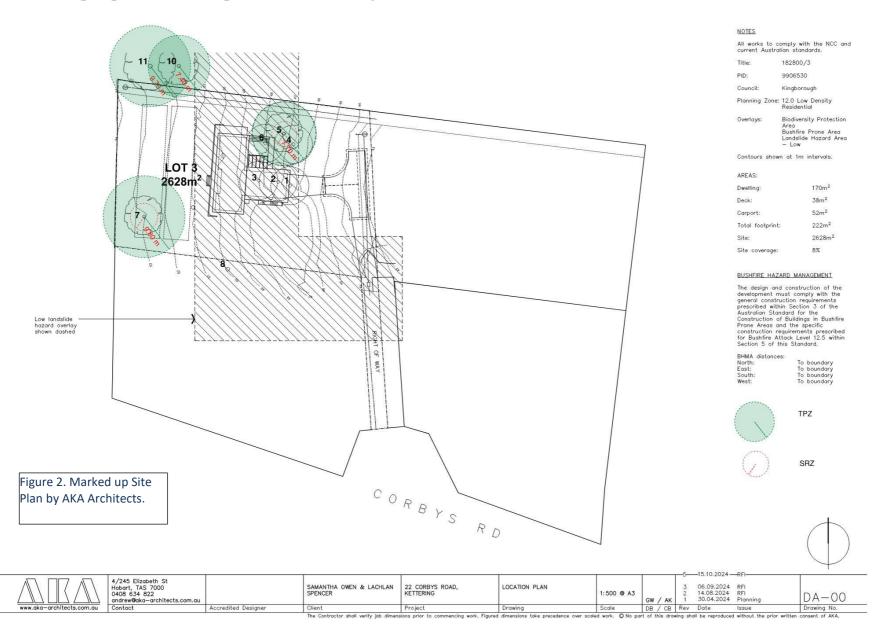
3. The proposed development and nearby trees

The proposed works have potential to impact on nine nearby trees, including two trees standing in neighbouring properties.

Construction of the proposed design would result in the removal of five black gums of high conservation value. The modest size of the property, location of the existing trees and dam, proposed dwelling and services infrastructure all contribute to the necessary removal of these trees.

Tree 5 is expected to satisfactorily cope with an encroachment of 13% over its TPZ. Retention of this tree is encouraged.

TREE	SPECIES	Sig.	DAB	DBH	H/S	SRZ	TPZ	FEATURES	ENCROACHMENT	Enc %	Ret.	Rem_Reas
1	E. ovata	Н	0.67	0.59	F/F	2.8	7.1	Trunk leans to south-east. Decay in trunk at 4 m above the ground. Poor crown form, heavily biased to southeast. Moderate size dead branches.	Car port / dwelling	>50	N	Within dwelling footprint
2	E. ovata	Н	0.83	0.63	F/F	3.1	7.6	Trunk leans to north-east. Decay in lower trunk. Bark dieback on large upper crown scaffold.	Car port / dwelling	>50	N	Within dwelling footprint
3	E. ovata	Н	0.87	0.68	P/F	3.1	8.2	Trunk leans to north-east - heave apparent on western side of root plate. Poor crown form. Crown includes large dead branches - in decline.	Car port / dwelling	>50	N	Within dwelling footprint
4	E. ovata	Н	0.65	0.54	F/P	2.8	6.5	Heavily decayed tall stump with mature re-growth. Trunk has failed in the past at 5 m above the ground.			N	Poor structure - Hazard
5	E. ovata	Н	0.79	0.64	F/F	3	7.7	Historic storm damage - large wound on upper trunk. Long scaffolds.	Deck, Raised bed	13	Y

6	E. ovata	Н	0.75	0.64	G/G	2.9	7.7		Deck	>50	N	Within deck footprint
7	E. pulchella	VH	1	0.82	F/P	3.3	9.8	Trunk leans to south. Extensive decay in lower trunk and primary roots. No hollows observed.	Drainage and AWTS discharge area infrastructure	>50	Pos see section 5

REE	SPECIES	Sig.	DAB	DBH	H/S	SRZ	TPZ	FEATURES	ENCROACHMENT	Enc	Ret.	
										%		Rem_Reas
10	E. globulus 'Compacta'	Н		0.62	G/G		7.4	At 25A Selbys Rd			Υ	
11	E. globulus	VH		0.81	G/G		9.7	At 25A Selbys Rd	Cut-off drain	2	Υ	
S								Old stump

- There is adequate scope for establishment of tree protection zones within 3/22 Corbys Rd around trees 10 and 11.
 - The TPZ's should be clearly marked with barrier tape and generally exclude:

- excavation,
 - movement by machinery,
 - storage or disposal of building materials.
 - Excavator access along the footprint of the cut-off drain within the TPZ of tree 11 is permissible and has been considered as part of this assessment. It is unlikely that large roots (>50mm in diameter) of tree 11 will be exposed during this excavation. Any exposed roots should be cleanly cut with a saw beyond the excavator damage.

- Tree 5 TPZ will be impacted by deck construction pier footings and a sleeper retained raised planter bed. An exclusion zone should be set up around this tree along the edge of the planter bed and up to 1m beyond the northern edge of the deck footprint to facilitate construction.

- Limitations to TPZ access and storage outlined above must be followed.
 - Machinery use for pier footing excavation is permissible from within the footprint of the dwelling and driveway. Otherwise, the deck and sleeper retaining wall post footings are to be excavated by hand.

- Tree 7 stands within the footprint of the proposed AWTS discharge area. The cut-off drain will have a significant impact on the tree's root volume and natural downslope water flow to the east. Retention of this tree is possible with the reticulation infrastructure within the TPZ of tree 7 installed along the existing soil surface and covered with mulch, essentially forming a mulch bed that could be further planted out, if desired. The AWTS discharge will provide supplementary irrigation, off-setting to some degree the root damage and change to soil drainage patterns caused by the cut-off drain.

- o In ground installation of the reticulation infrastructure within the TPZ of tree 7 is expected to cause excessive damage to the tree's roots. Inground installation within the TPZ would necessitate removal of tree 7.
