**Arboricultural Assessment
Report**

**3643 Channel Highway, Birches Bay,
7162, TAS**

Tree Pioneers
ABN: 97 327 587 243
33 Ballantyne Heights, Franklin,
Tasmania, 7113

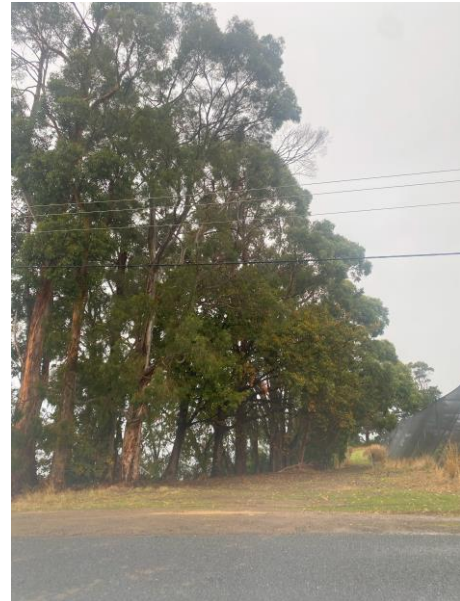
Figure 1. Image showing the entrance to the sight.

The site access has 16 trees on the adjacent crown land that require assessment. None of these trees are impacted by the proposed development. Tree Protection measures are to be erected to ensure the trees remain viable.

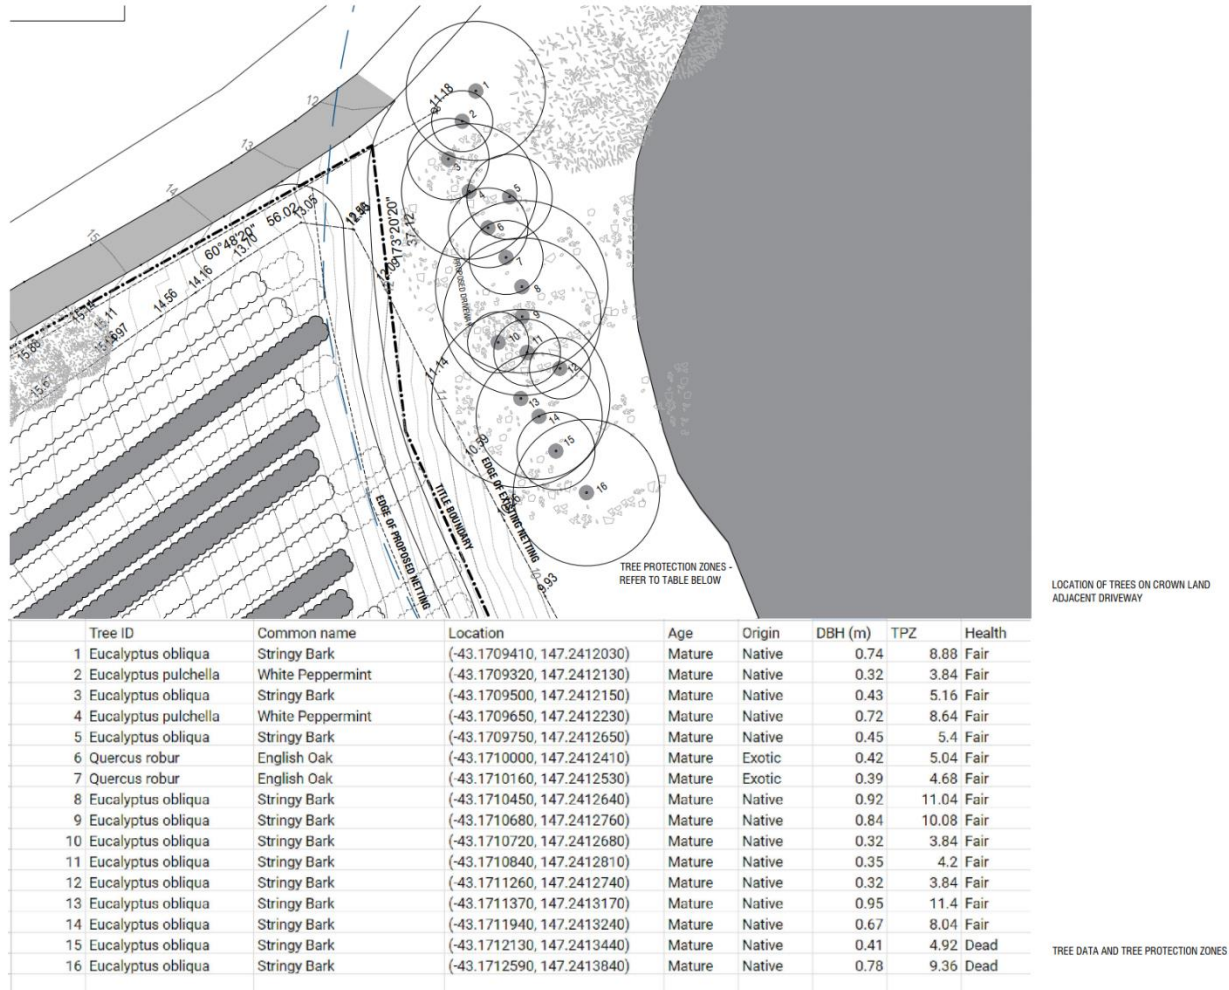
Figure 4. Site plans for the proposed development showing Tree Protection Zones (TPZ). Image shows no encroachment from proposed development.
 Provided by Irene Inc.

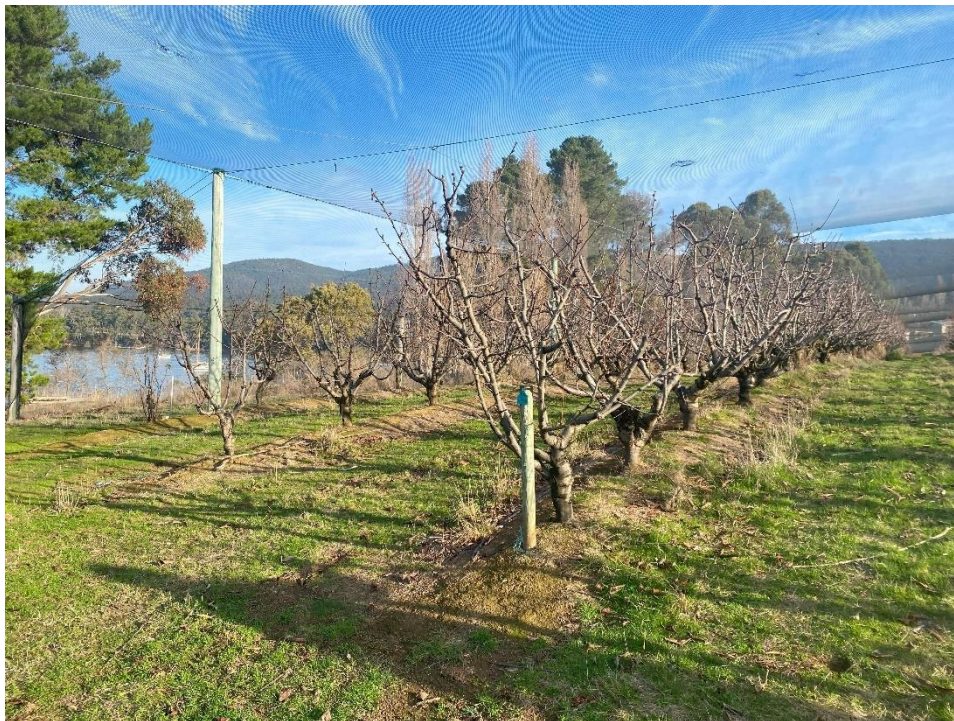
The cherry trees growing in the area proposed for development appear to be smaller in height and have a smaller trunk size compared to the other trees. They also have significantly more deadwood present in their canopy. The number of buds present of these trees are significantly fewer than elsewhere on the farm. The extension growth between buds is shorter in length compared to trees elsewhere. The farm is tree lined along the coast at all parts of the site except for this Eastern boundary. The exposed eastern section of the site presents a hostile environment for tree growth. This section of the site has less protection for crops. Exposure to wind and salt spray are among elements which are contributing to a poor growing environment.

Figure 5. Image of the cherry trees at the edge of the site where the proposed development is. Noticeably reduced size and thinner canopy than the rest of site.

The proposed plan to relocate the position of the crops to a more protected and viable area is sound. It will allow for the building to shield crops from harsh coastal environment.

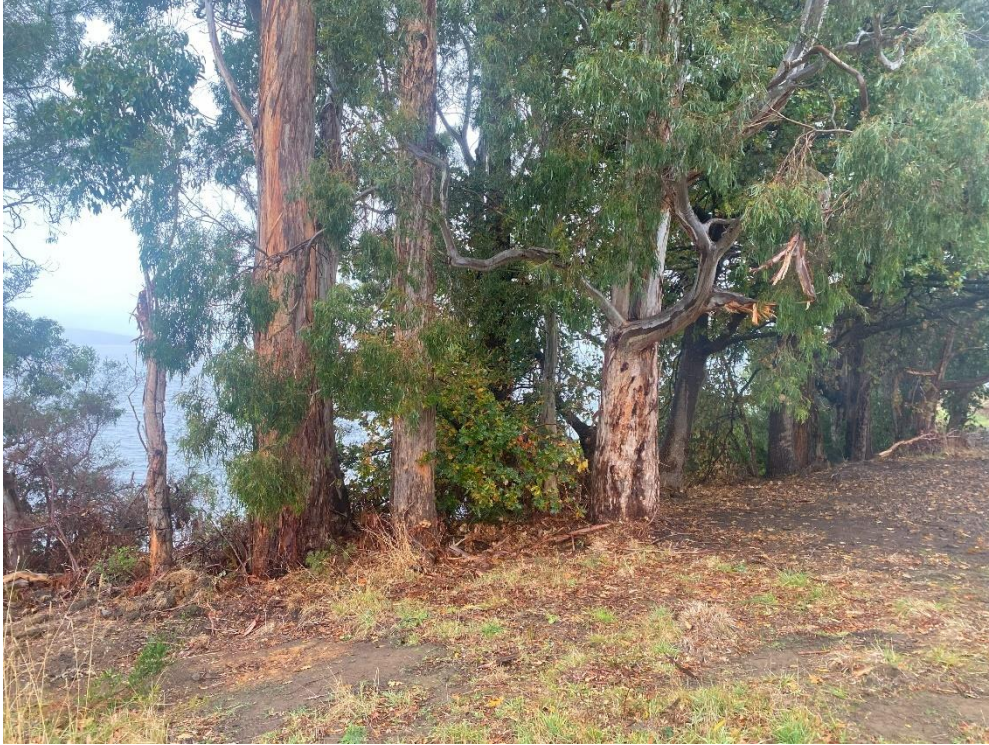
The proposed access to the site runs along the northern boundary. The driveway access borders crown land which has 15 large trees. There are no trees with encroachment.

These trees have no encroachment and will not be affected by development.

Figure 6. Images of the tree 1 -5. Larger trees which are closest to the site.

- Installation of Tree Protection Zones (TPZ) fences. Figure 9 shows a typical TPZ fence. This method is not practical for every individual tree in Crown land. A strained wire fence with orange bunting at the edge of the proposed driveway which will be the boundary between the site and crown land.
- Install TPZ 2 meters from cherry trees being retained to ensure there is no damage to trees or growing environment. A strained wire fence with orange bunting along the length of the rows to exclude access for construction material, plant and workers.
- A sign installed on the Tree protection zone and along TPZ fences to ensure no access to area.
- Appoint a site arborist.
- Inspection by site arborist to 'sign off' Tree Protection measures implementation.

- Install driveway without entering the Tree Protection Zone.
