PROPOSED VISITOR ACCOMMODATION 117 CONINGHAM ROAD CONINGHAM

GEOTECHNICAL SUMMARY

SITE (SOIL TEST) CLASSIFICATION

September 2024

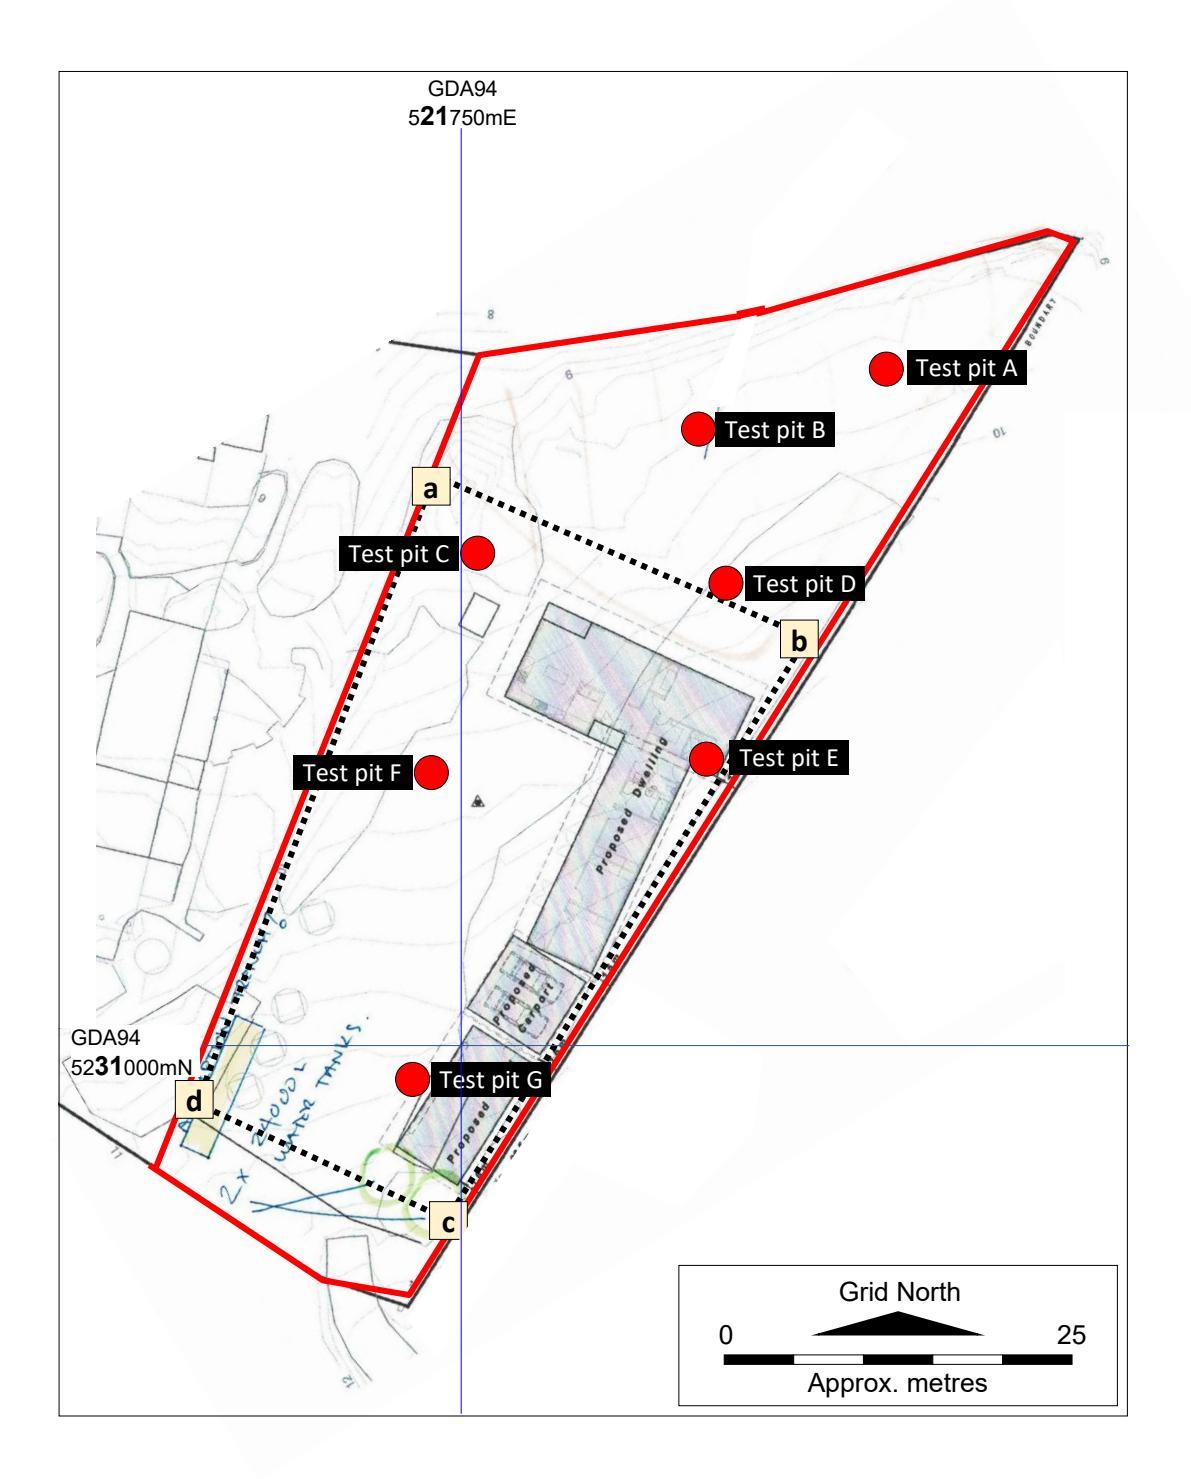
Site sketch showing test pit locations, and the area abcd to which the AS2870 site classification in Attachment 4 applies

In accordance with Australian Standard 2870 (2011) *Residential slabs and footings* the area **abcd** in Attachment 2 is classed as **Class S** provided all house footings are founded in Layers 4, 5, or 6 (Table 4.1) beneath the Layer 3 subsoil (where it exists).

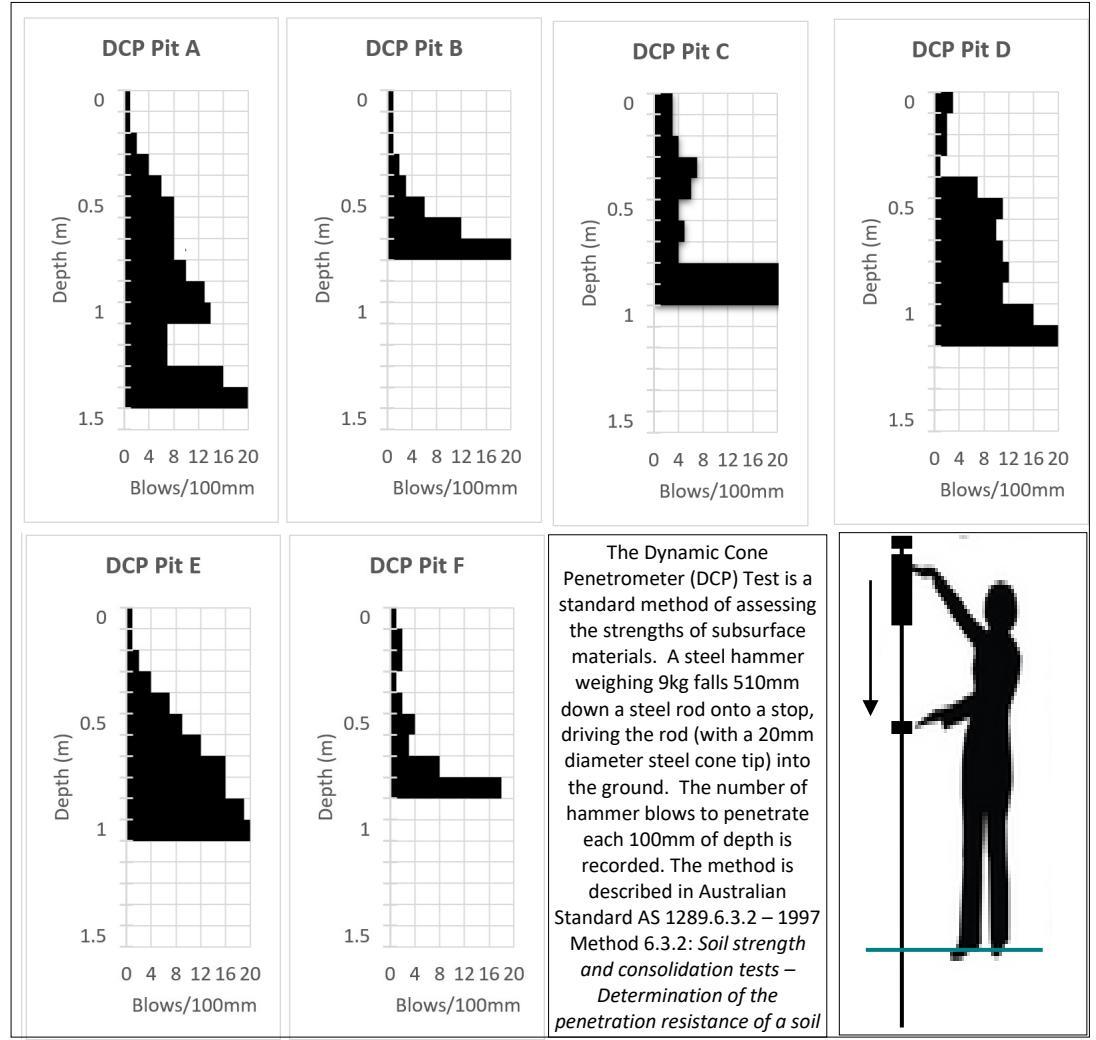
Figure 4.1 DCP profiles next to test pits A - F. See Figure 4.2 for published correlations between DCP values and some soil properties.

- The Layer 1 and 2 topsoil in all cases is of low strength, with DCP blows/100mm in the range 1 – 2 (ABC <100kPa).
- Strength generally (but not always) increases in the Layer 3 subsoil, with DCP blows/100mm typically in the 8 16 range (ABC 200 400kPa)

ABC more than about 100kPa is generally sufficient to support a house⁶. House footings should be placed beneath the Layer 1, 2 and 3 materials.
