BUSHFIRE HAZARD REPORT

Proposed shed 50 Delta Avenue, Taroona, 7053

Dated 26th November 2024 Report by David Lyne BFP-144

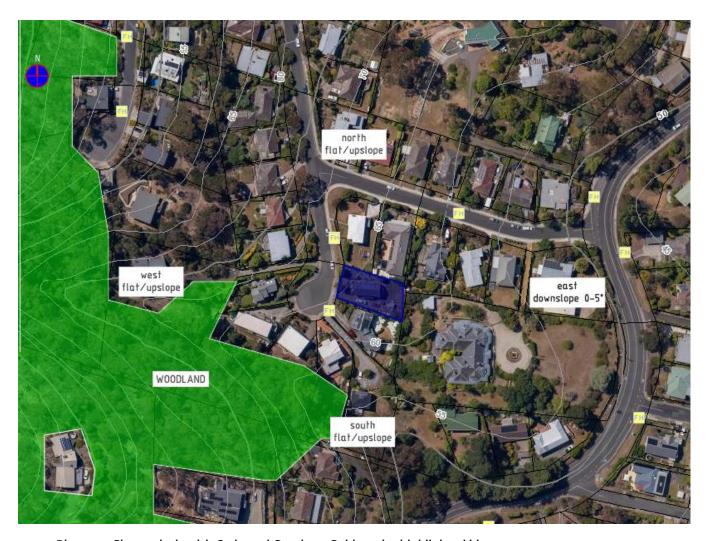
Photo 1 - Site analysis with Cadastral Overlay - Subject site highlighted blue.

Note: in a bushfire there is a possibility of fire attack from any direction, not just the direction of the highest hazard. Photo 1, above indicates the Bushfire Prone Vegetation described. Refer to Appendix B for current conditions as at time of inspection.

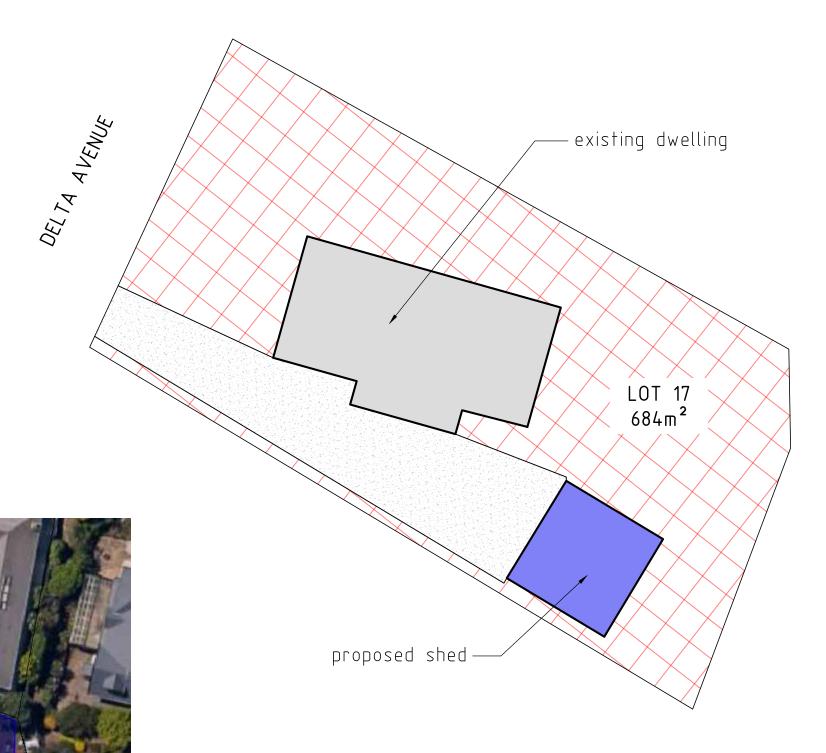
BHMP SCALE 1:200

HAZARD MANAGMENT AREA Low threat, maintained vegetation in accordance with AS 3959 -Clause 2.2.3.2 (e) & (f). Building is to be constructed to meet BAL-12.5 requirements

Vegetation in the Hazard Management area is to be managed and maintained in $\boldsymbol{\alpha}$ minimum fuel condition.

- MAINTENANCE SCHEDULE
 Removal of fallen limbs, leaf and bark litter;
- Cut lawns short (less than 100mm) and maintain;
- Remove pine bark and other garden mulch;

- Complete under-brushing and thin out the under storey; Prune low hanging trees to ensure separation from ground litter; Prune larger trees to establish and maintain horizontal and vertical canopy
- Maintain storage of petroleum fuels;
- Maintain access to the dwelling and water storage area Remove fallen limbs, leaf and bark litter from roofs, gutters and around the building;
