# LANDSLIP RISK ASSESSMENT

Alterations & Additions - Residential Dwelling

8 Meath Avenue Taroona TAS 7053

27/11/2024

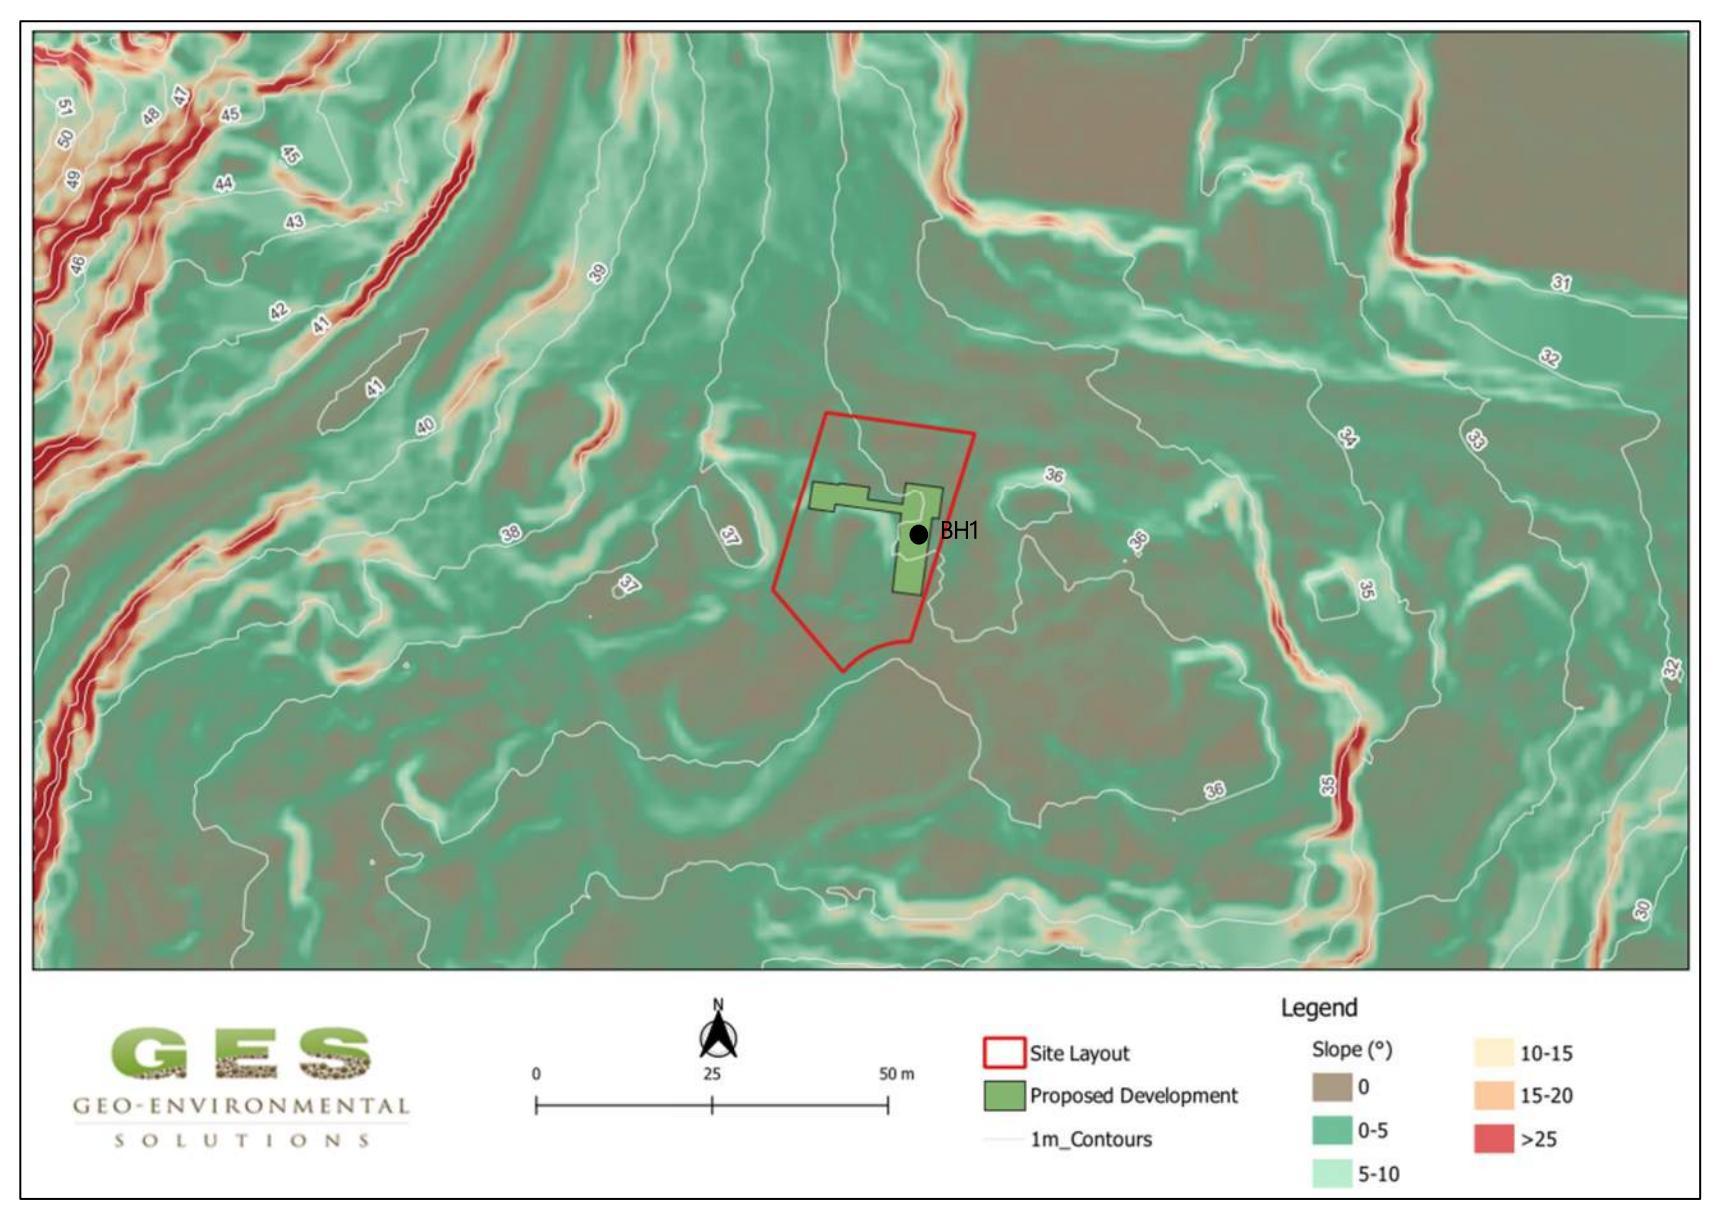
Figure 5 - Slope model developed from Kingborough 1m-2022 LiDAR data (borehole approx. location in black)

The project area is positioned on east and southeast facing slope. The proposed development occupies the area situated along the northern and eastern portion of the site. Elevation on the site is approximately at 36 meters above the Australian Height Datum (AHD) across the site. The dwelling sits on gentle slopes, exhibiting gradients between 5 to 10 degrees. To depict the onsite slope angles, a slope gradient map was generated using QGIS software and Kingborough 2022 LiDAR data (refer to Figure 5).

A site visit was undertaken on 16<sup>th</sup> of August wherein a single bore hole was completed to identify the distribution and variation of the soil materials at the site. Table 2 provides a summary of the ground conditions encountered in BH01 (refer Figure 5 for approx. locations).

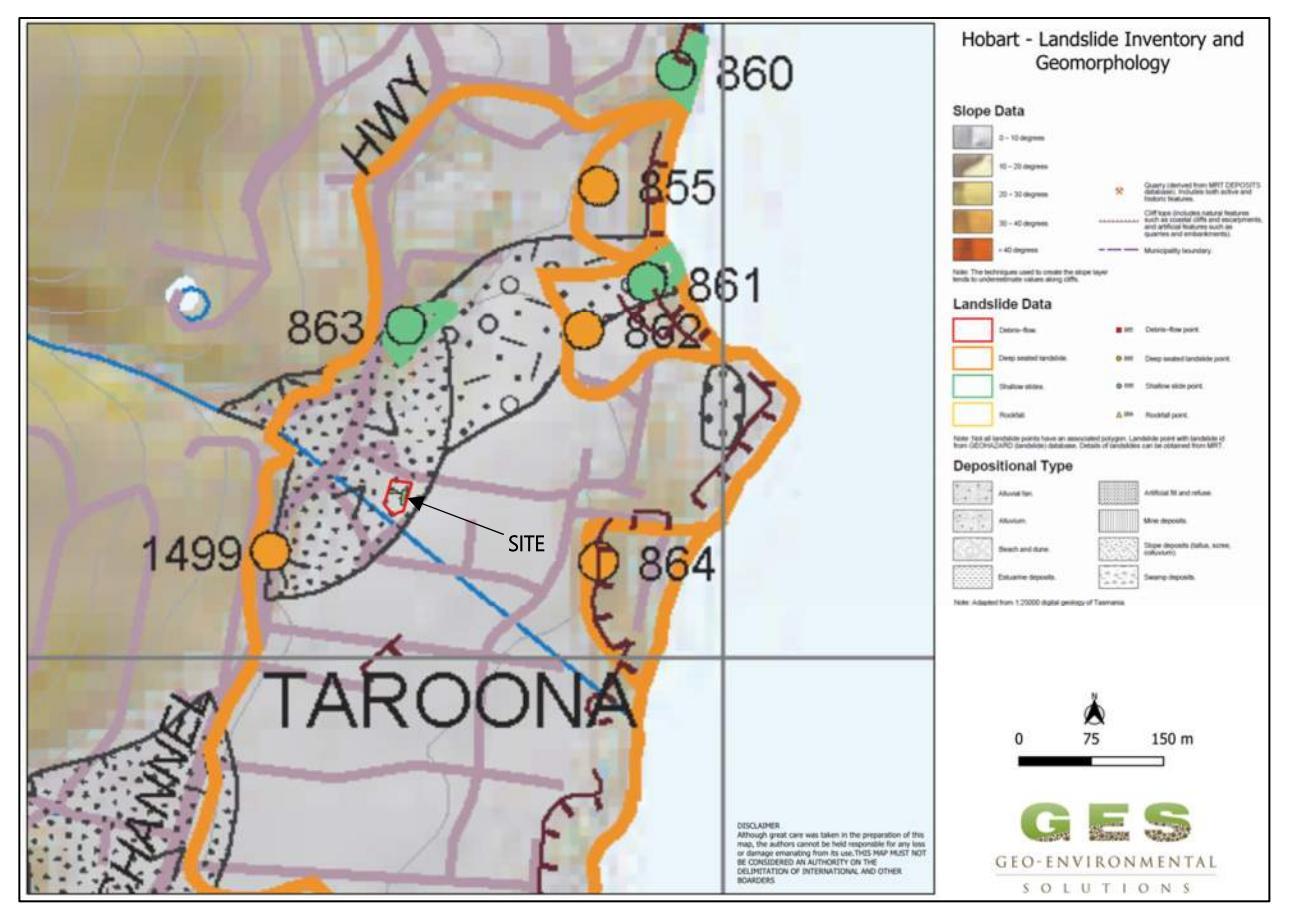
Figure 6 – Hobart landslide inventory map (Mazengarb 2004) with overlay of proposed development (in green) within the site (layout shown in red)

The MRT mapping shows the site to be located on an active earth translational slide (deep seated) with coastal deep-seated slides to the north and south of the site. The head scarp of the Taroona landslide is located approximately 200 m west of the site following the alignment of the Channel Highway. The site itself is located on the southern flank of the landslide. (Figure 6). Table 3 presents a summary of landslides, within similar geological and geomorphological settings to the site.

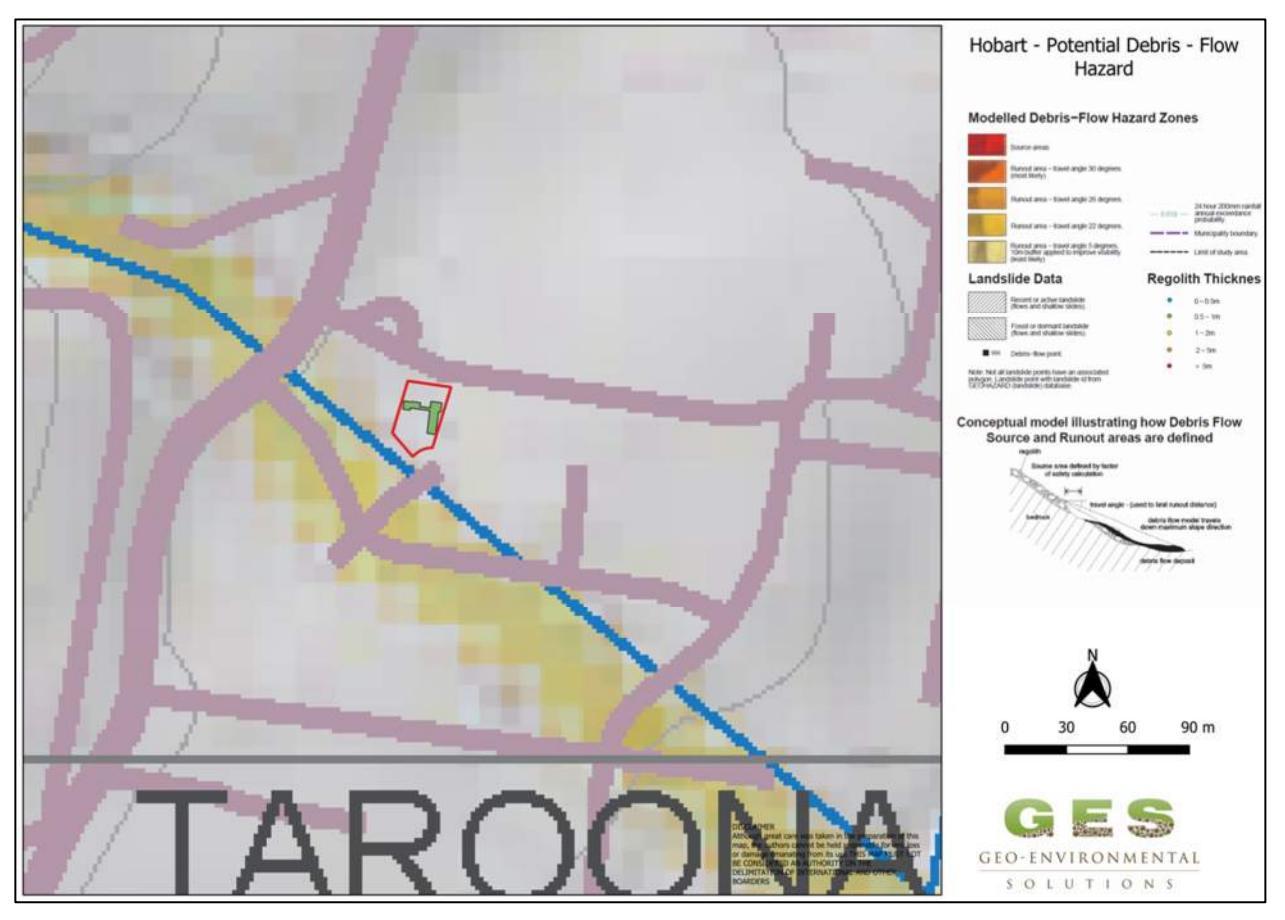
Figure 7 – Hobart shallow slide and flow susceptibility map (Mazengarb 2004) with overlay of proposed development (in green) within the site (layout shown in red)

No shallow slide and flow run-out hazard has been identified below the site (Figure 7). A runout area has been identified south of the site, following the alignment of a drainage line.

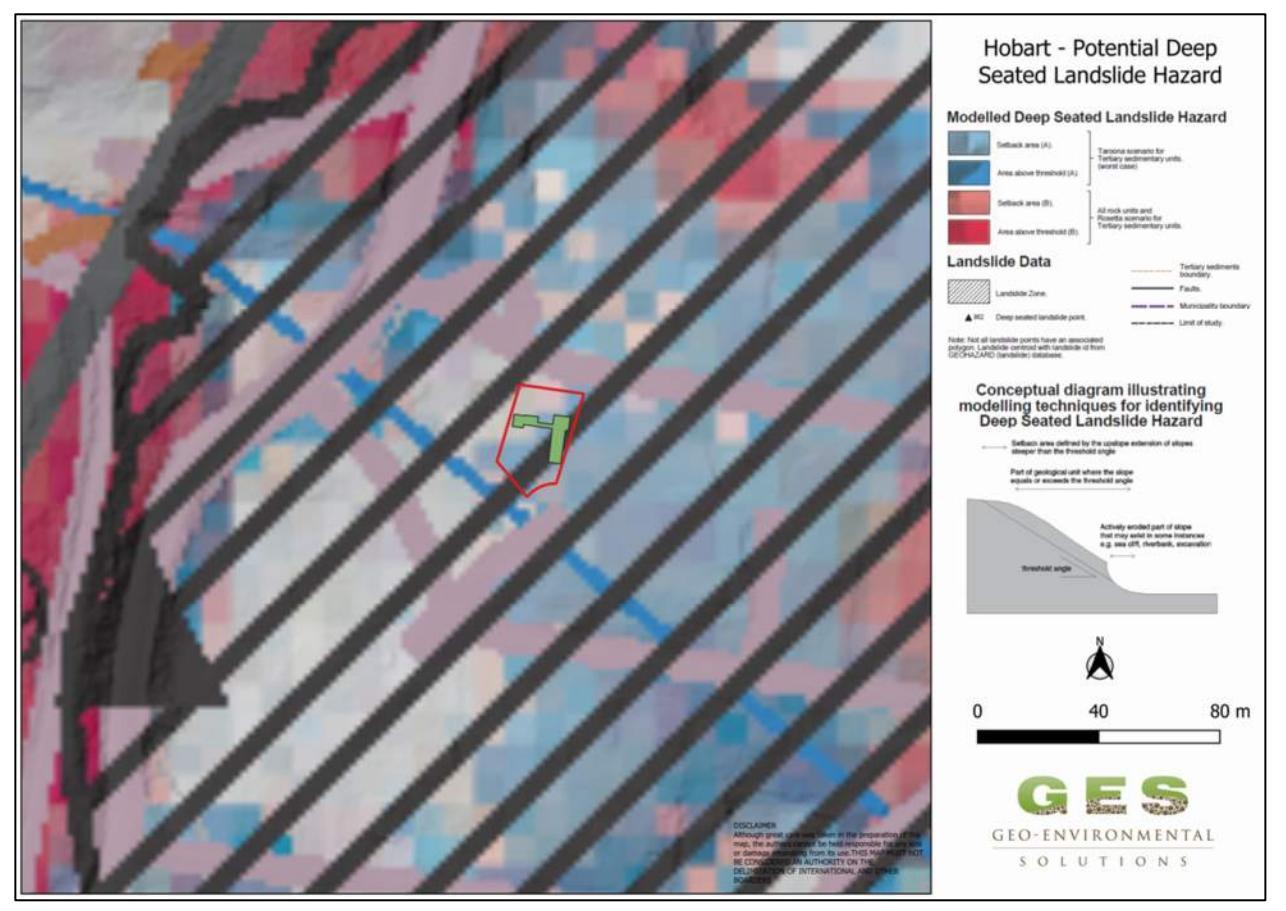
Figure 8 – Hobart deep seated landslide susceptibility map (Mazengarb 2004) with overlay of proposed development (in green) within the site (layout shown in red)

Deep seated slope instability has been identified based on the underlying geology and the slope angles in and around the vicinity of the site (refer Figure 7). The development area on site has been classified by MRT as 'Setback Area (A)', which is based on a threshold angle of 10° for Tertiary Sediments (based on tertiary sediments encountered at Taroona).

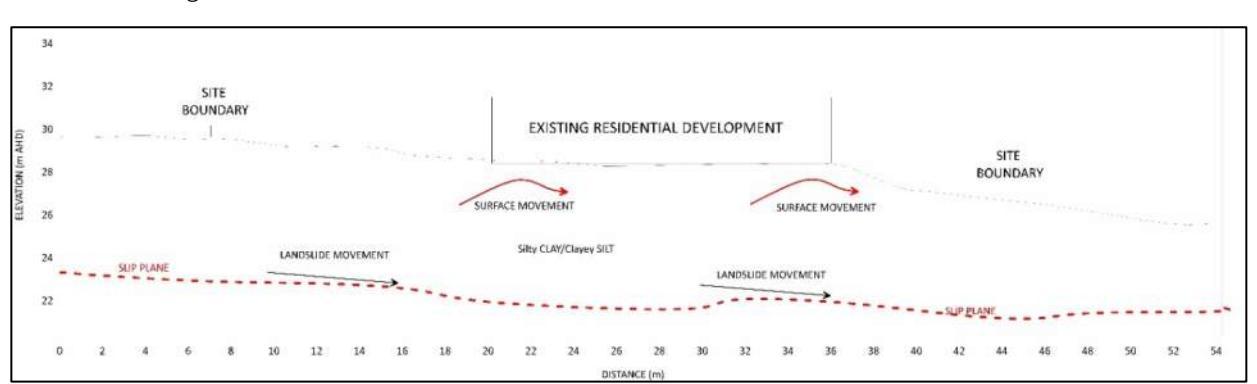
Figure 9 - Conceptual Cross Section of Slope Failure Mechanism relevant to the site (Not to scale)

Scenario 1 – Deep seated rotational slide through dep seated clay impacting pool walls leading to potential for water leakage and subsequent excess subsurface moisture impacting adjacent buildings

This scenario has been presented have been presented in the figure above, showing the typical slope failure plane of a deep-seated failure occurring directly under the proposed development. The failure plane depth is unknown. However, undulations in the slip plane are likely to result in differential ground surface movement at the site.

It is strongly recommended for the building to be founded on adjustable piers to allow for compensation of ground movement. This allows the building to move independent of the foundation system. Piers should extend to 4.5 m depth below the zone of surface movement (~2 m);
