ARBORICULTURAL IMPACT ASSESSMENT

<u>NEW DWELLING & ASSOCIATED</u> <u>INFRASTRUCTURE</u>

75 BLYTH PARADE GREAT BAY 7150

V2 DECEMBER 2024

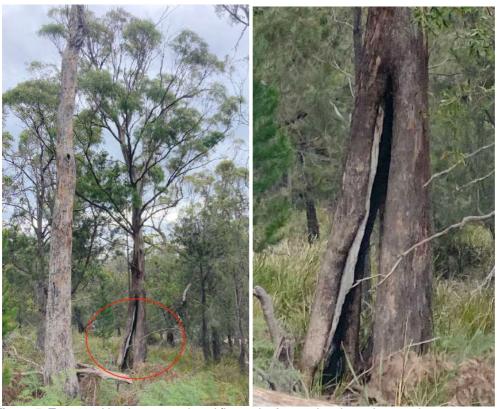
NOTE: Tree 19 has a very large basal fire cavity that has resulted in opposite open trunk faces (figure 5). There presently appears to be sufficient reaction wood associated with the open cavity faces to provide adequate structural stability, however this may be diminished if the tree continues to experience increasingly reduced vitality. As such the tree may develop an increasing likelihood of failure and accordingly it should be inspected regularly (i.e annually) to assess its likelihood of failure and associated risk.

Figure 5: Tree 19 with a large open basal fire cavity & associated reaction wood

5.2.2.1 Construction of the vehicle access will result in an unacceptable level of encroachment on the TPZ area of HCV trees 10 (20%), 12(14%) & 19(14%). These trees exhibit signs of significant physiological stress such that they would not tolerate the level of root damage & soil disturbance that will be incurred by the proposed access construction works. However it is likely that the works can be successfully achieved with tolerable long term impact to the subject trees if appropriate protective measures are properly implemented and controlled in accordance with the tree protection measures outlined in Items 6.4 & 6.6 of the Tree Protection Specification. Specifically, the access works should be constructed above the present surface grade employing non-destructive, non-compacting 'no dig' methodology within the TPZ/SRZ of trees 10, 12 & 19.
