Arboriculture Impact Assessment – Kingborough Council

STAGE 2, NORTH WEST BAY MULTI-USE TRAIL

Client	Kingborough Council
Contact	Su Sprott
Phone	6211 8278
Email	ssprott@kingborough.tas.gov.au
Job Ref no.	QU-226
Date	16/11/2024
Version History	1.0

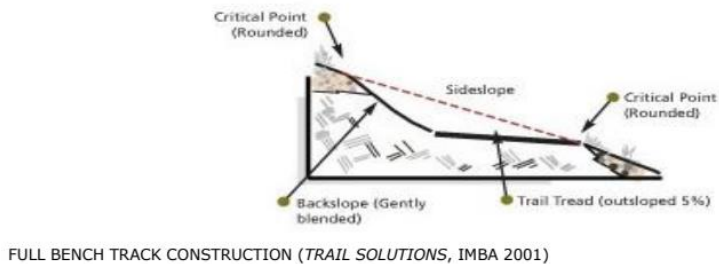
<p>FULL BENCH TRACK CONSTRUCTION (TRAIL SOLUTIONS, IMBA 2001)</p>	High
Heavy Bench Construction

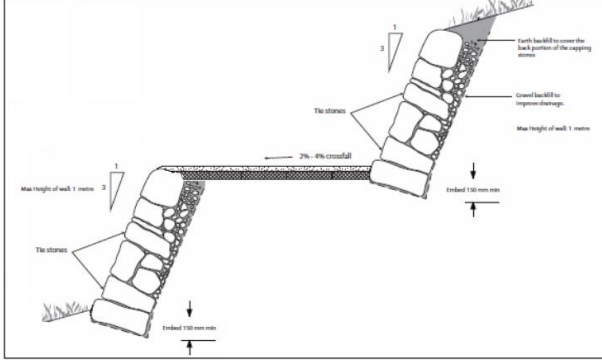
<p>HEAVY BENCHING - PARTIAL BENCH - HB</p>	High
Medium Bench Construction

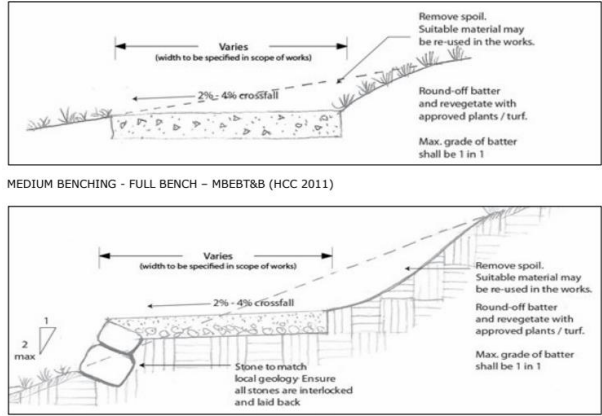
<p>MEDIUM BENCHING - FULL BENCH - MBEBT&B (HCC 2011)</p> <p>MEDIUM BENCHING - PARTIAL BENCH - MBEBT (HCC 2011)</p>	Medium

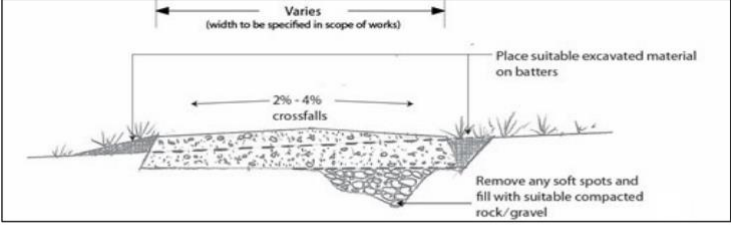
<p>LOW BENCHING (HCC 2011)</p>	<p>Low</p>
<p>Rock Armour Construction</p>

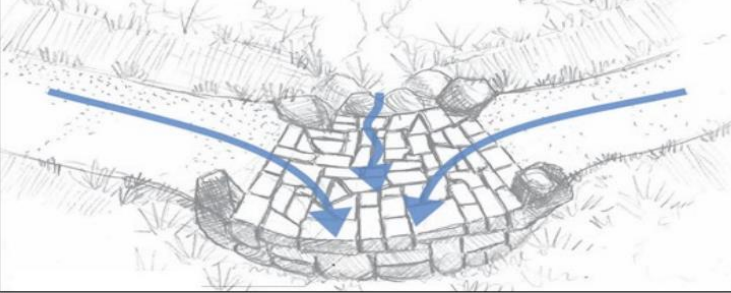
<p>ROCK ARMOURING / PAVING (HCC 2011)</p>	<p>Medium</p>

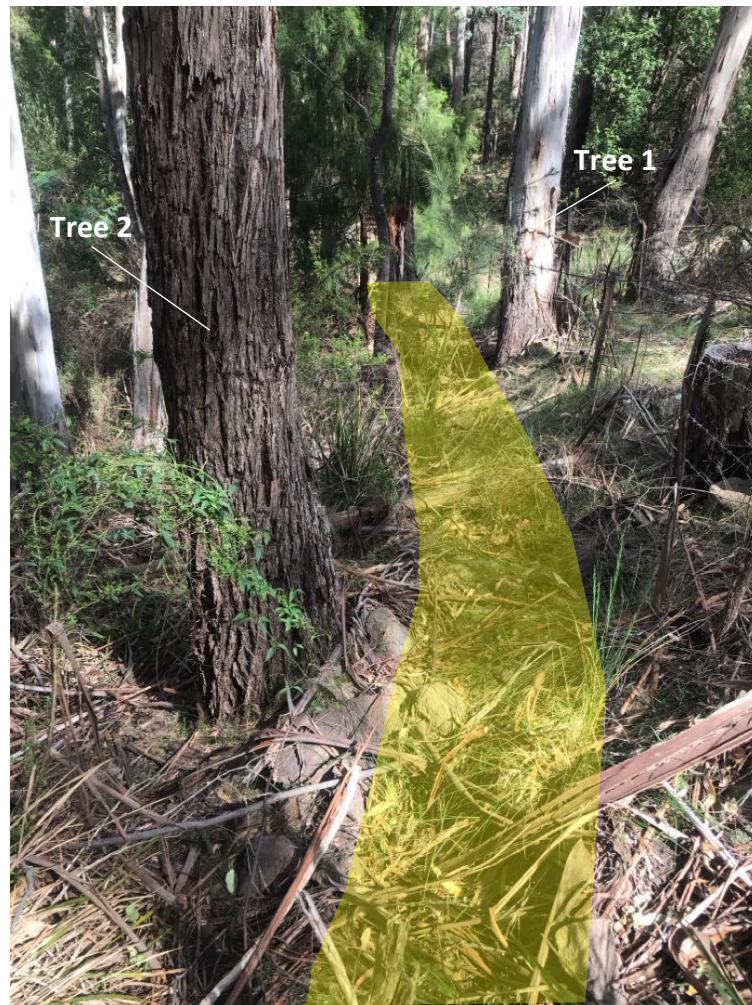
Figure 2. Trees 1 and 2 in relation to the proposed track alignment, which will require medium to heavy benching due to the steep slope of the hill. The yellow shading indicates the approximate track alignment. This positioning is necessary to accommodate constraints such as exclusion zones for threatened fauna and property tenure restrictions.

Tree no.	Species	DBH	TPZ	DAB	SRZ	Retention	Encroachment
Tree 1	<i>Eucalyptus viminalis</i>	.55m	6.6m	.66m	2.7m	Y	35%
Tree 2	<i>Eucalyptus globulus</i>	.46m	5.5m	.55m	2.5m	Y	33%
Tree 3	<i>Eucalyptus globulus</i>	.52m	6.2m	.6m	2.6m	Y	28%

- Avoid the cut-and-fill method within 3 meters of trees; limit excavation depth to 100mm.
- Increase the trail grade by using rocks or fill from outside the TPZ rather than reducing the grade or cutting into the bank.
- Avoid building up soil against tree trunks; instead, use rocks or boulders to prevent contact with the trunk.
- For rock armour, limit excavation depth to 200mm or less.
- Preserve all roots greater than 50mm in diameter; avoid cutting or damaging these roots.

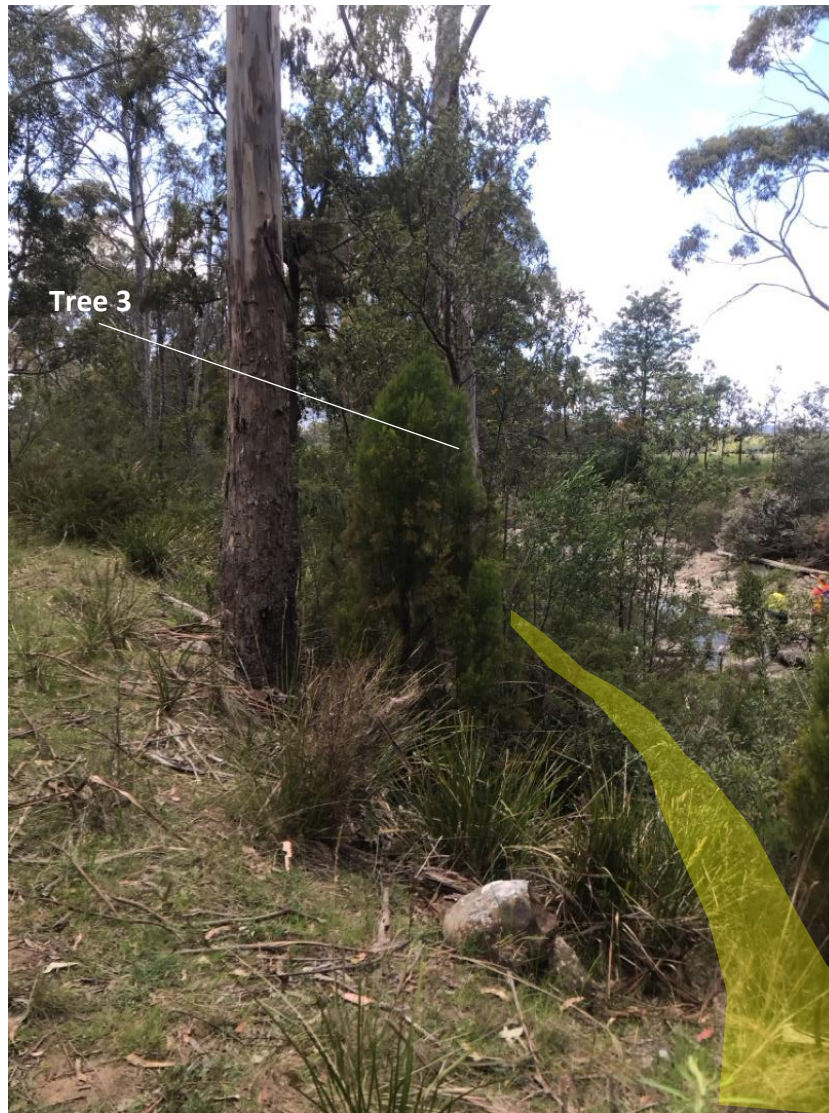
Figure 3. Tree 3, a *Eucalyptus globulus*, is visible in the background. The proposed track, indicated by the yellow shading, traverses a steep slope to provide access to the river crossing.

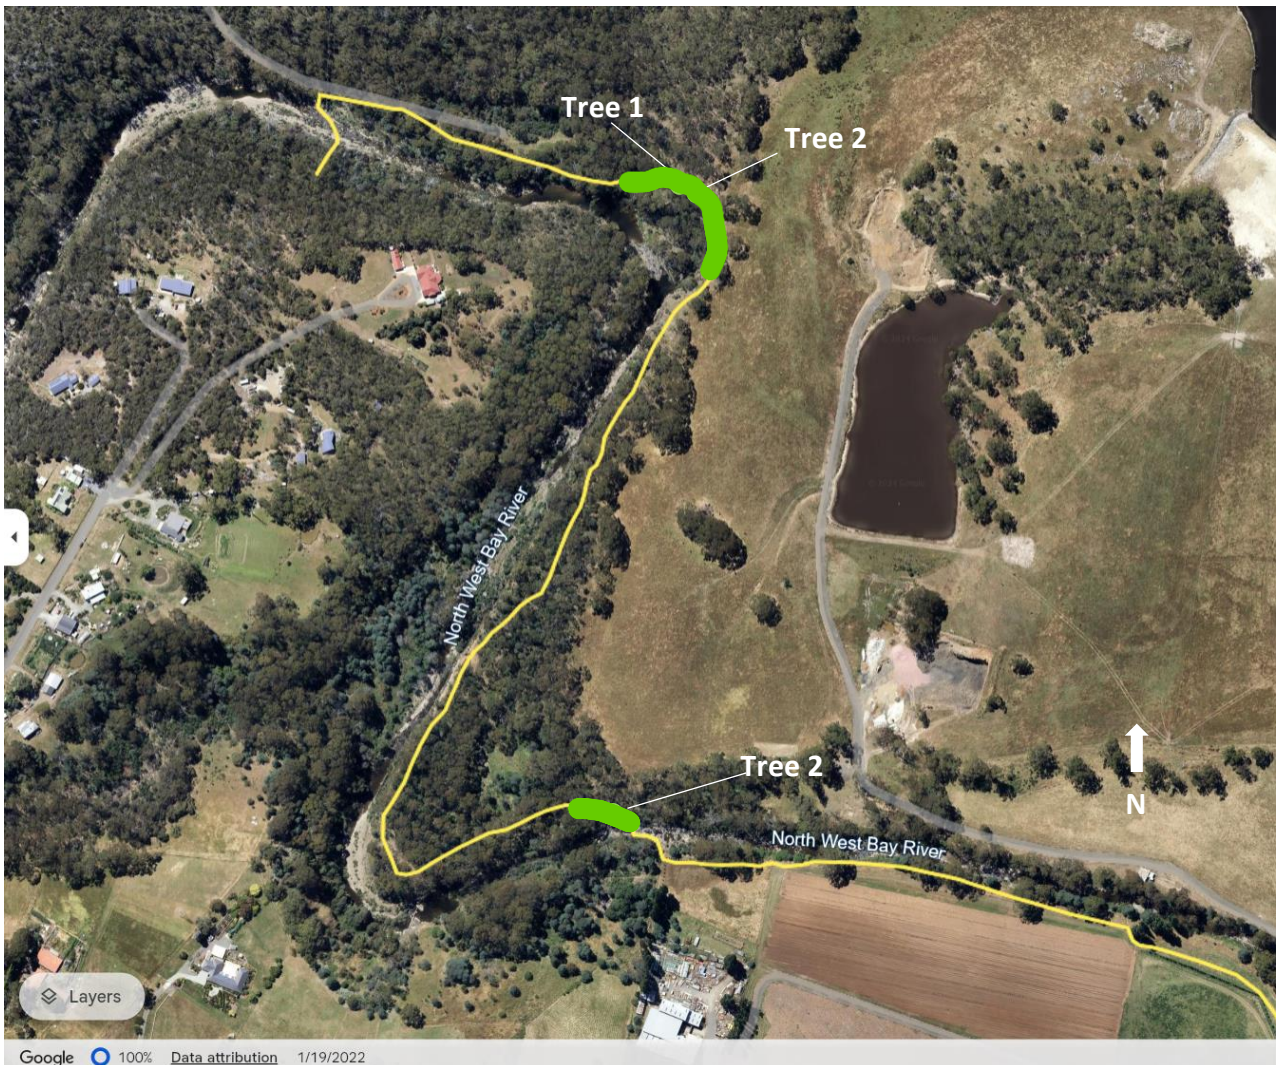
Negative impacts on the trees may result from development activities that disrupt the root system or physically damage the tree. It is essential to identify areas of the track requiring medium or heavy benching (figure 4) and understand all activities within the TPZs (table 3) to be able to mitigate impacts effectively.

Figure 4. Sections of the North West Bay Track requiring “Medium” or “Heavy Benching” type construction are highlighted in green, as outlined in the North West Bay River Multi-use Trail Feasibility Study. These construction methods have the potential to impact nearby trees.

Potential impacts	Reason	Mitigation measures
Excavation for Medium and Heavy Benching	Roots can be severed, affecting the tree's structural stability or ability to uptake nutrients and water.	Minimise excavation depth to remain above natural grade. Use fill to create the trail base instead of excavation. Preserve all roots >50mm diameter.
Excavation for Rock Armour Drainage or Crossings	Roots may be severed, compromising stability and nutrient/water uptake.	Minimise excavation depth to remain above natural grade. Use fill to raise trail grade and reduce excavation. Preserve all roots >50mm diameter.
Building Up Fill Against Trunk	Soil piled against the trunk can cause decay and damage the cambium layer, inhibiting nutrient uptake.	Prevent fill from touching the tree trunk. Use boulders or permeable stone walls for support near the trunk if necessary.
Physical Injury from Excavator Movements	Machinery can damage roots, trunks, or branches, causing structural issues or entry points for pathogens.	Provide a spotter to guide machinery movements within the TPZ. Limit excavator size to a maximum of 3-tonne capacity.
