LANDSLIDE ASSESSMENT REPORT

203 Woodbridge Hill Road
Woodbridge

January 2024

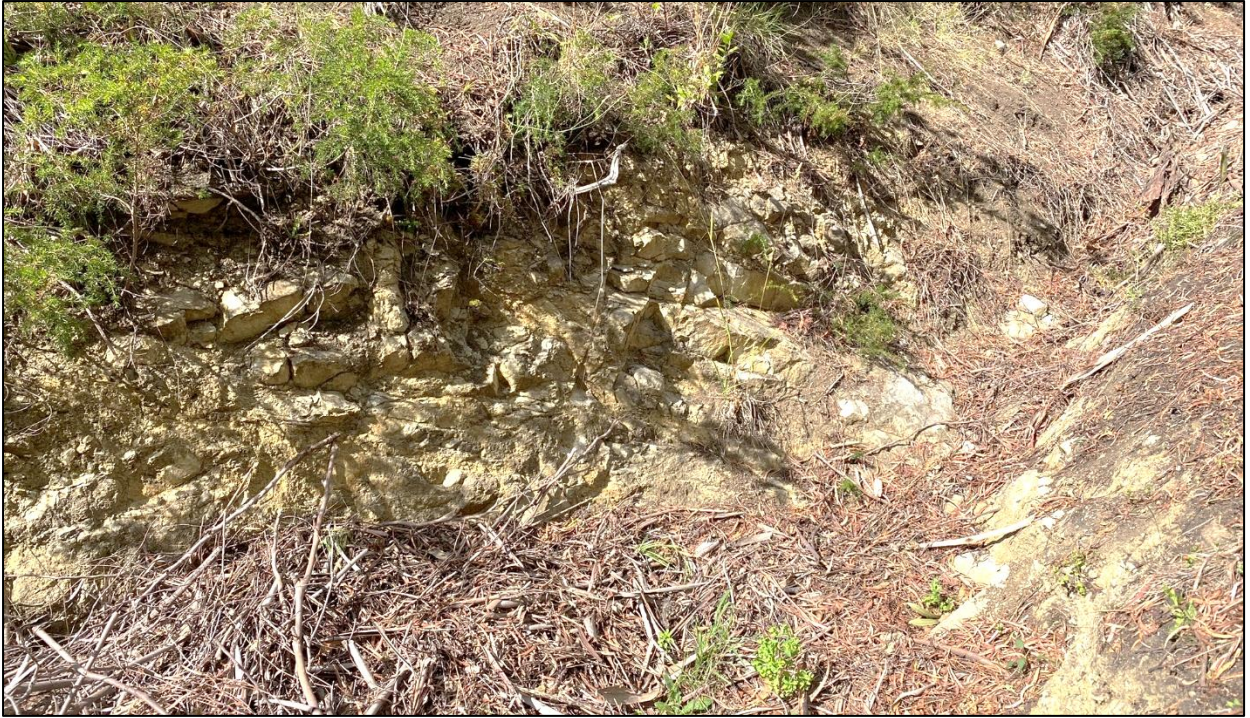
The soil profiles are formed from clayey colluvium derived from Jurassic dolerite with common dolerite floaters in the upper horizons. The profiles are moderately shallow with test hole and DCP refusal on weathered dolerite bedrock occurring between 0.75 and 1.0 m (see Figure 3 below)

Figure 3: Shallow cutting into the hard weathered dolerite bedrock. Cutting forms the roadside stormwater drain at the north of the site.

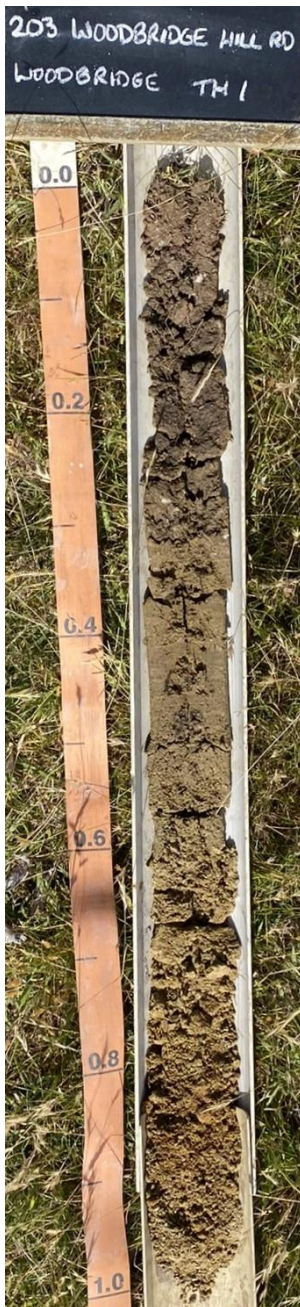
Test Hole 1

Depth (m)	Horizon	Description and field texture grade	USCS Class
0 – 0.05	A1	Brown (10YR 4/3) Sandy Light Clay , strong fine angular blocky structure, single grain, dry medium dense consistency, abundant roots.	CL/CH
0.05 – 0.3	B2 ₁	Brown (10YR 5/3) with organic coatings of peds/down cracks, Gritty Light Clay , strong medium angular blocky structure, slightly moist stiff consistency, few roots, few gravels.	CL/CH
0.3 – 0.6	B2 ₂	Light olive brown (2.5Y 5/3) Gritty Light Clay , massive breaking to weak coarse blocky structure.	CL/CH
0.6 – 0.8	BC	Light yellowish brown (2.5Y 6/4) Gritty Clay Loam , strong fine angular blocky structure, single grain, dry dense consistency.	SC
0.8 – 1.0	C _w	Mixed grey (2.5Y 5/1) and light olive brown (2.5Y 5/3), Clayey gravel , single grain, common dolerite gravels, dry dense consistency. <u>Refusal.</u>	GC

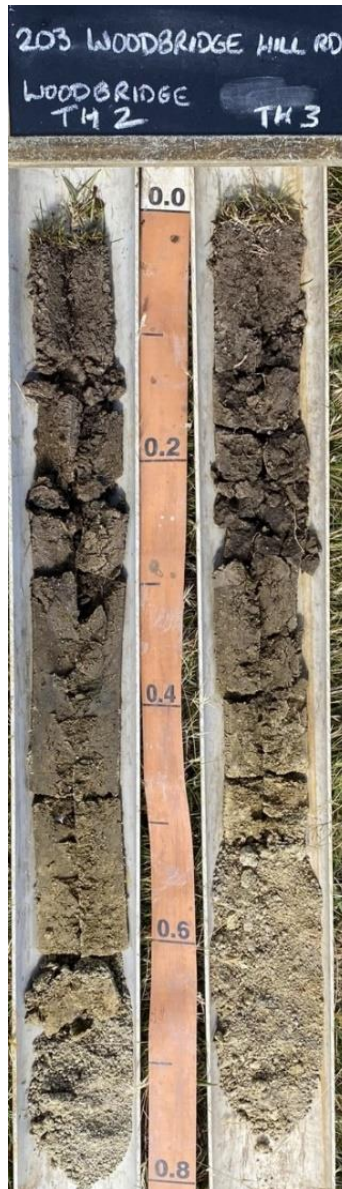
Depth TH2 (m)	Depth TH3 (m)	Horizon	Description and field texture grade	USCS Class
0 – 0.1	0 – 0.1	A1	Brown (10YR 4/3) Sandy Light Clay , strong fine angular blocky structure, single grain, dry medium dense consistency, abundant roots.	CL/CH
0.1 – 0.5	0.1 – 0.3	B2 ₁	Olive brown (2.5Y 4/3) Sandy Light Clay , massive breaking to weak medium blocky structure, few green mottles, slightly moist stiff consistency, trace of charcoal.	CL/CH
0.5 – 0.65	0.3 – 0.5	B2 ₂	Light yellowish brown (2.5Y 6/4), Gritty Light Clay , massive breaking to weak medium blocky structure, slightly moist firm consistency.	CL/CH
0.65 – 0.8	0.5 – 0.75	Cw	Mixed grey (2.5Y 5/1) and light olive brown (2.5Y 5/3), Clayey gravel , single grain, common dolerite gravels, dry dense consistency. <u>Refusal</u> .	GC

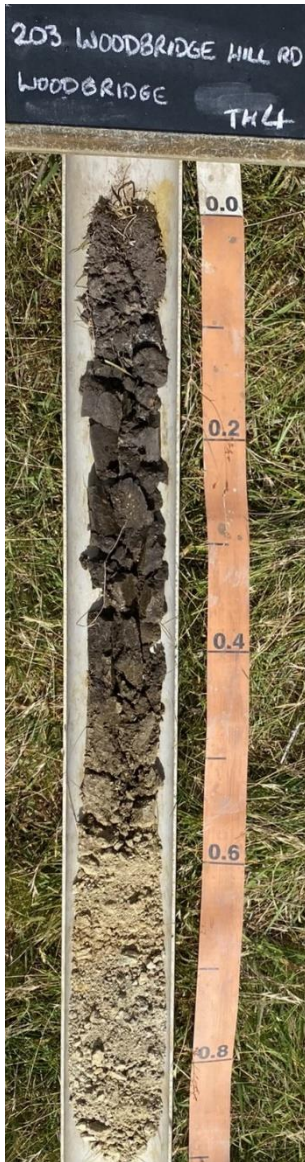
Test Hole 4

Depth (m)	Horizon	Description and field texture grade	USCS Class
0 – 0.1	A1	Brown (10YR 4/3) Sandy Light Clay , strong fine angular blocky structure, single grain, dry medium dense consistency, abundant roots.	CL/CH

0.1 – 0.5	B2 ₁	Olive brown (2.5Y 4/3) with organic coatings down cracks, Sandy Light Clay , strong medium angular blocky structure, few green mottles, slightly moist stiff consistency, trace of charcoal at 0.20 m.	CL/CH

0.5 – 0.6	B2 ₂	Light yellowish brown (2.5Y 6/4), Gritty Light Clay , massive breaking to weak medium blocky structure, slightly moist firm consistency.	CL/CH

0.6 – 0.7	BC ₁	Light yellowish brown (2.5Y 6/4) Gritty Clay Loam , strong fine angular blocky structure, single grain, dry dense consistency.	SC
0.7 – 0.9	CW	Mixed grey (2.5Y 5/1) and light olive brown (2.5Y 5/3), Clayey gravel , single grain, common dolerite gravels, dry dense consistency. <u>Refusal.</u>	GC
