# LANDSLIP RISK ASSESSMENT

Alterations & Additions - Residential Dwelling

8 Meath Avenue Taroona TAS 7053

27/11/2024

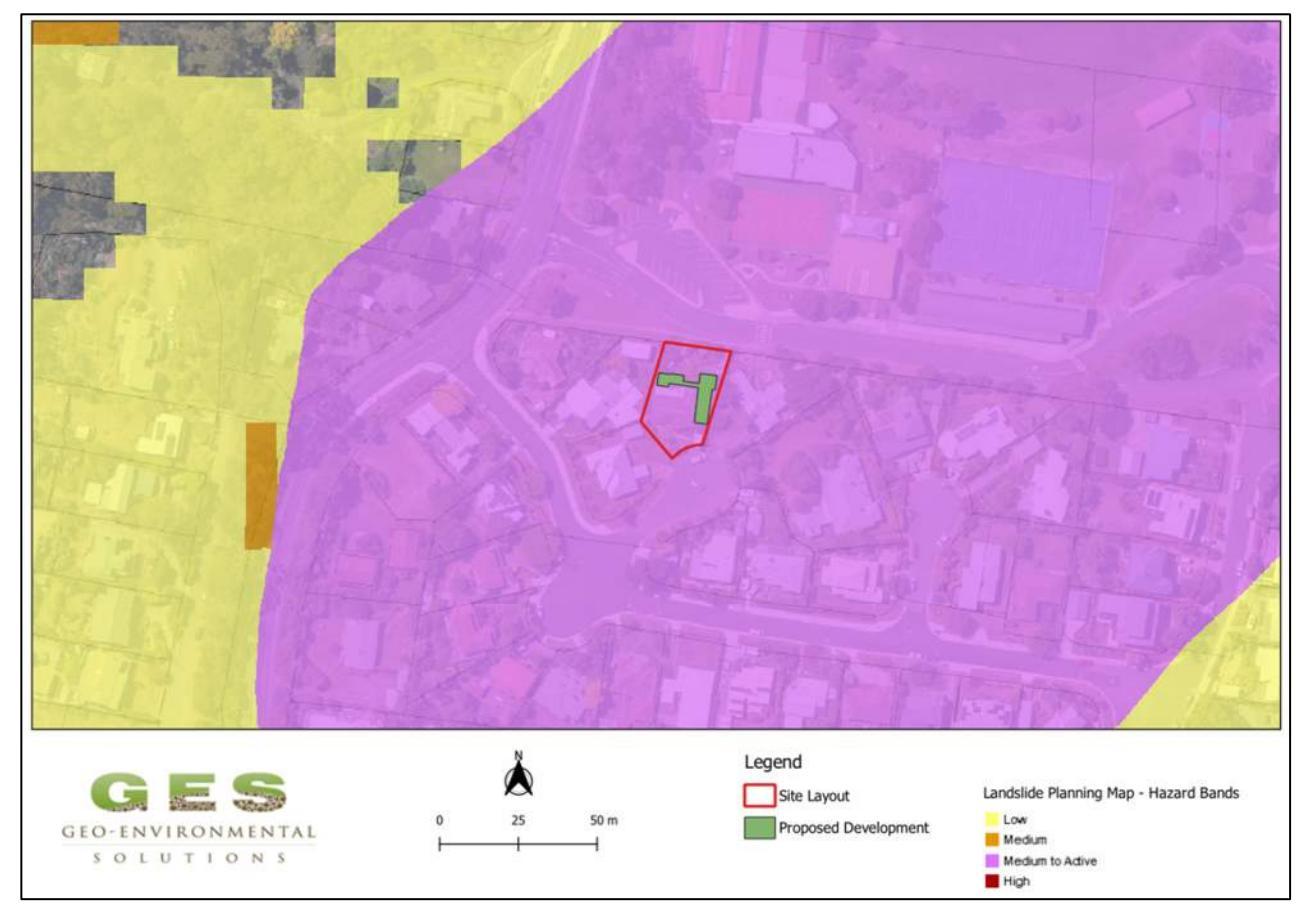
Figure 2 – Landslip Overlay at the Site (The List) with approximate location of proposed development

The site predominately lies within Medium-Active landslip overlay (Figure 2).

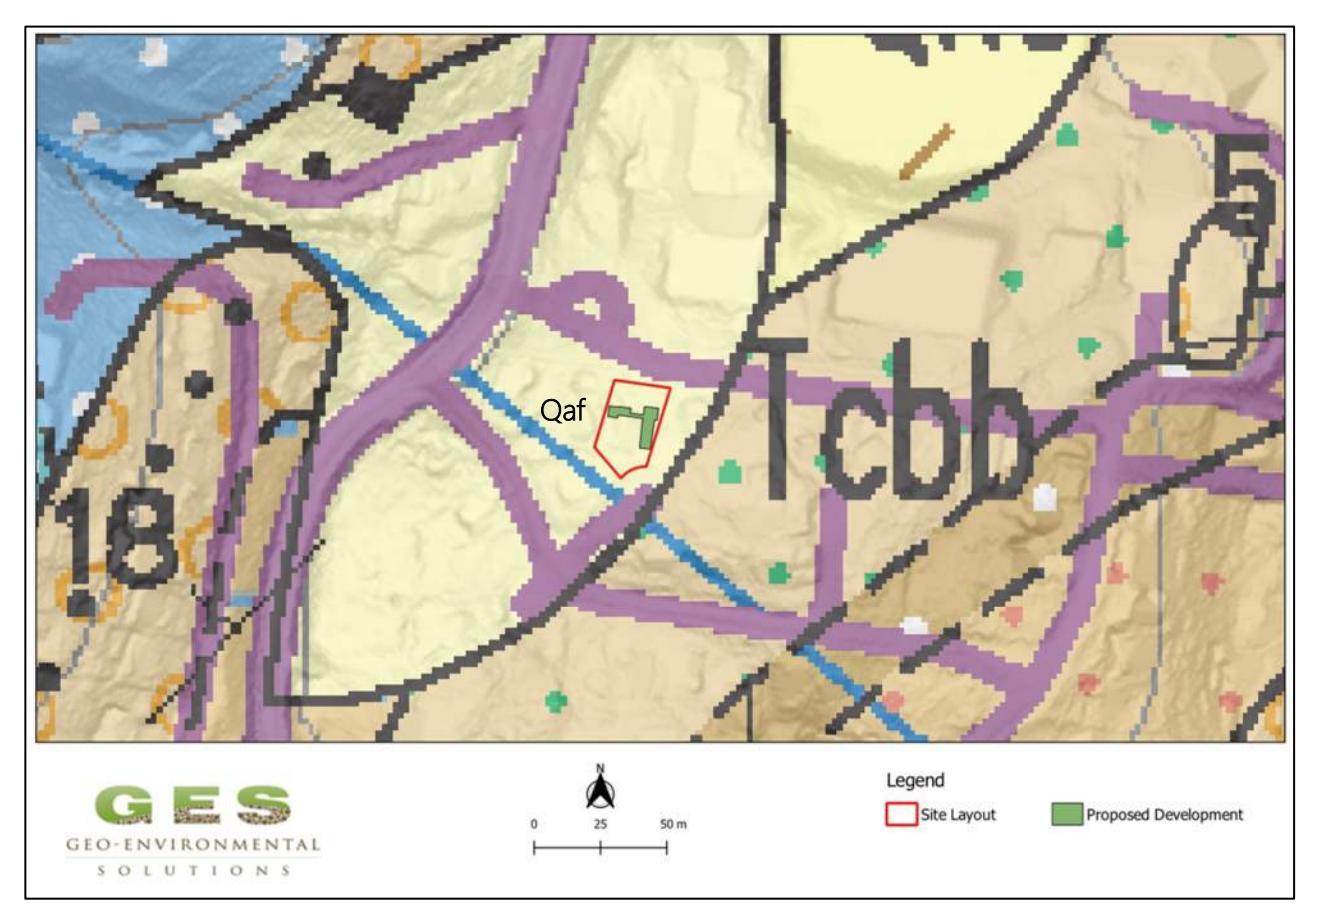
Figure 4 – Mapped geology (source: LIST Mapping 1:250,000); site shown in red outline

Based on the MRT 1:25,000 Mineral Resources Tasmania (MRT) mapping of Southeast Tasmania, the site geology comprises of the following geological unit (refer Figure 4):

• Map Unit – Qaf: Alluvial fans.

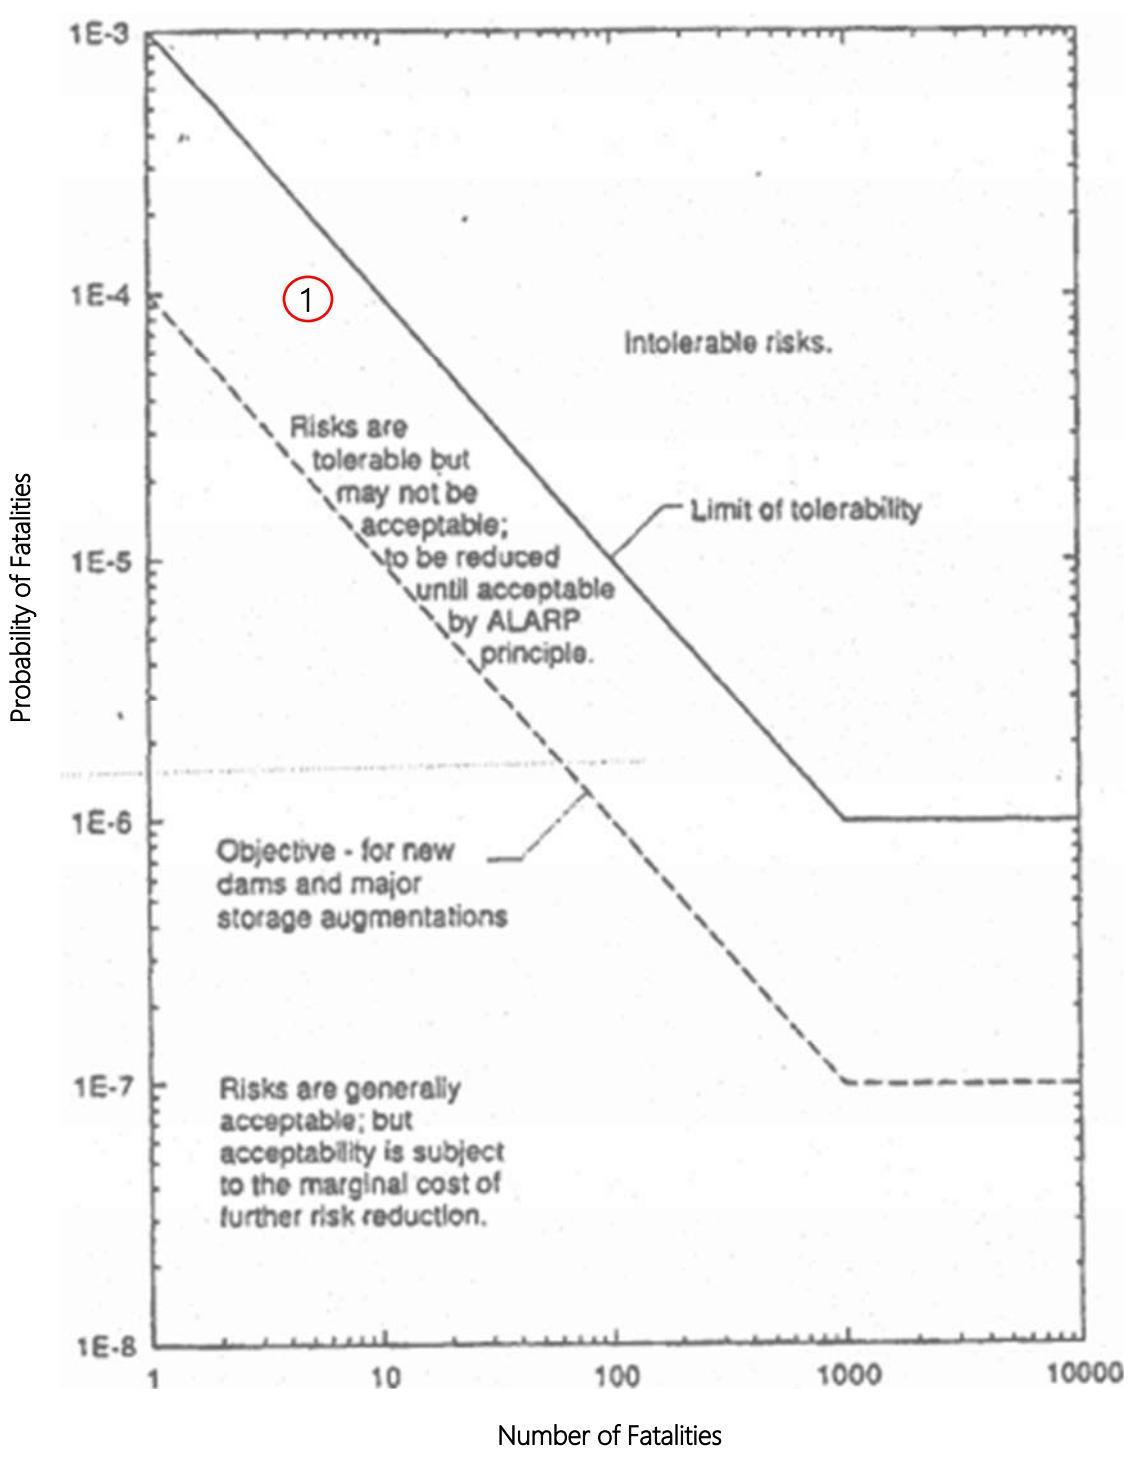
Figure 10 Societal Risk Graph of Probability of Fatalities vs Number of Fatalities (ANCOLD 1998)

The Societal Risk Graph plot presented in Figure 10. showing the estimated individual risks for scenarios 1 and 2 as presented in Figure 6 (outlined in the AGS 'Landslide Risk Management Concepts and Guidelines', 2000). The risks are estimated based on people in the structure spending up to 12 hours per day in internal areas the property.
