North West Bay River Multi-use Trail: Miandetta Drive to Channel Highway Natural Values Report & Environmental Management Plan

> Client: Kingborough Council Prepared by: Nick Fitzgerald & Andy Welling

14 MAY 2024

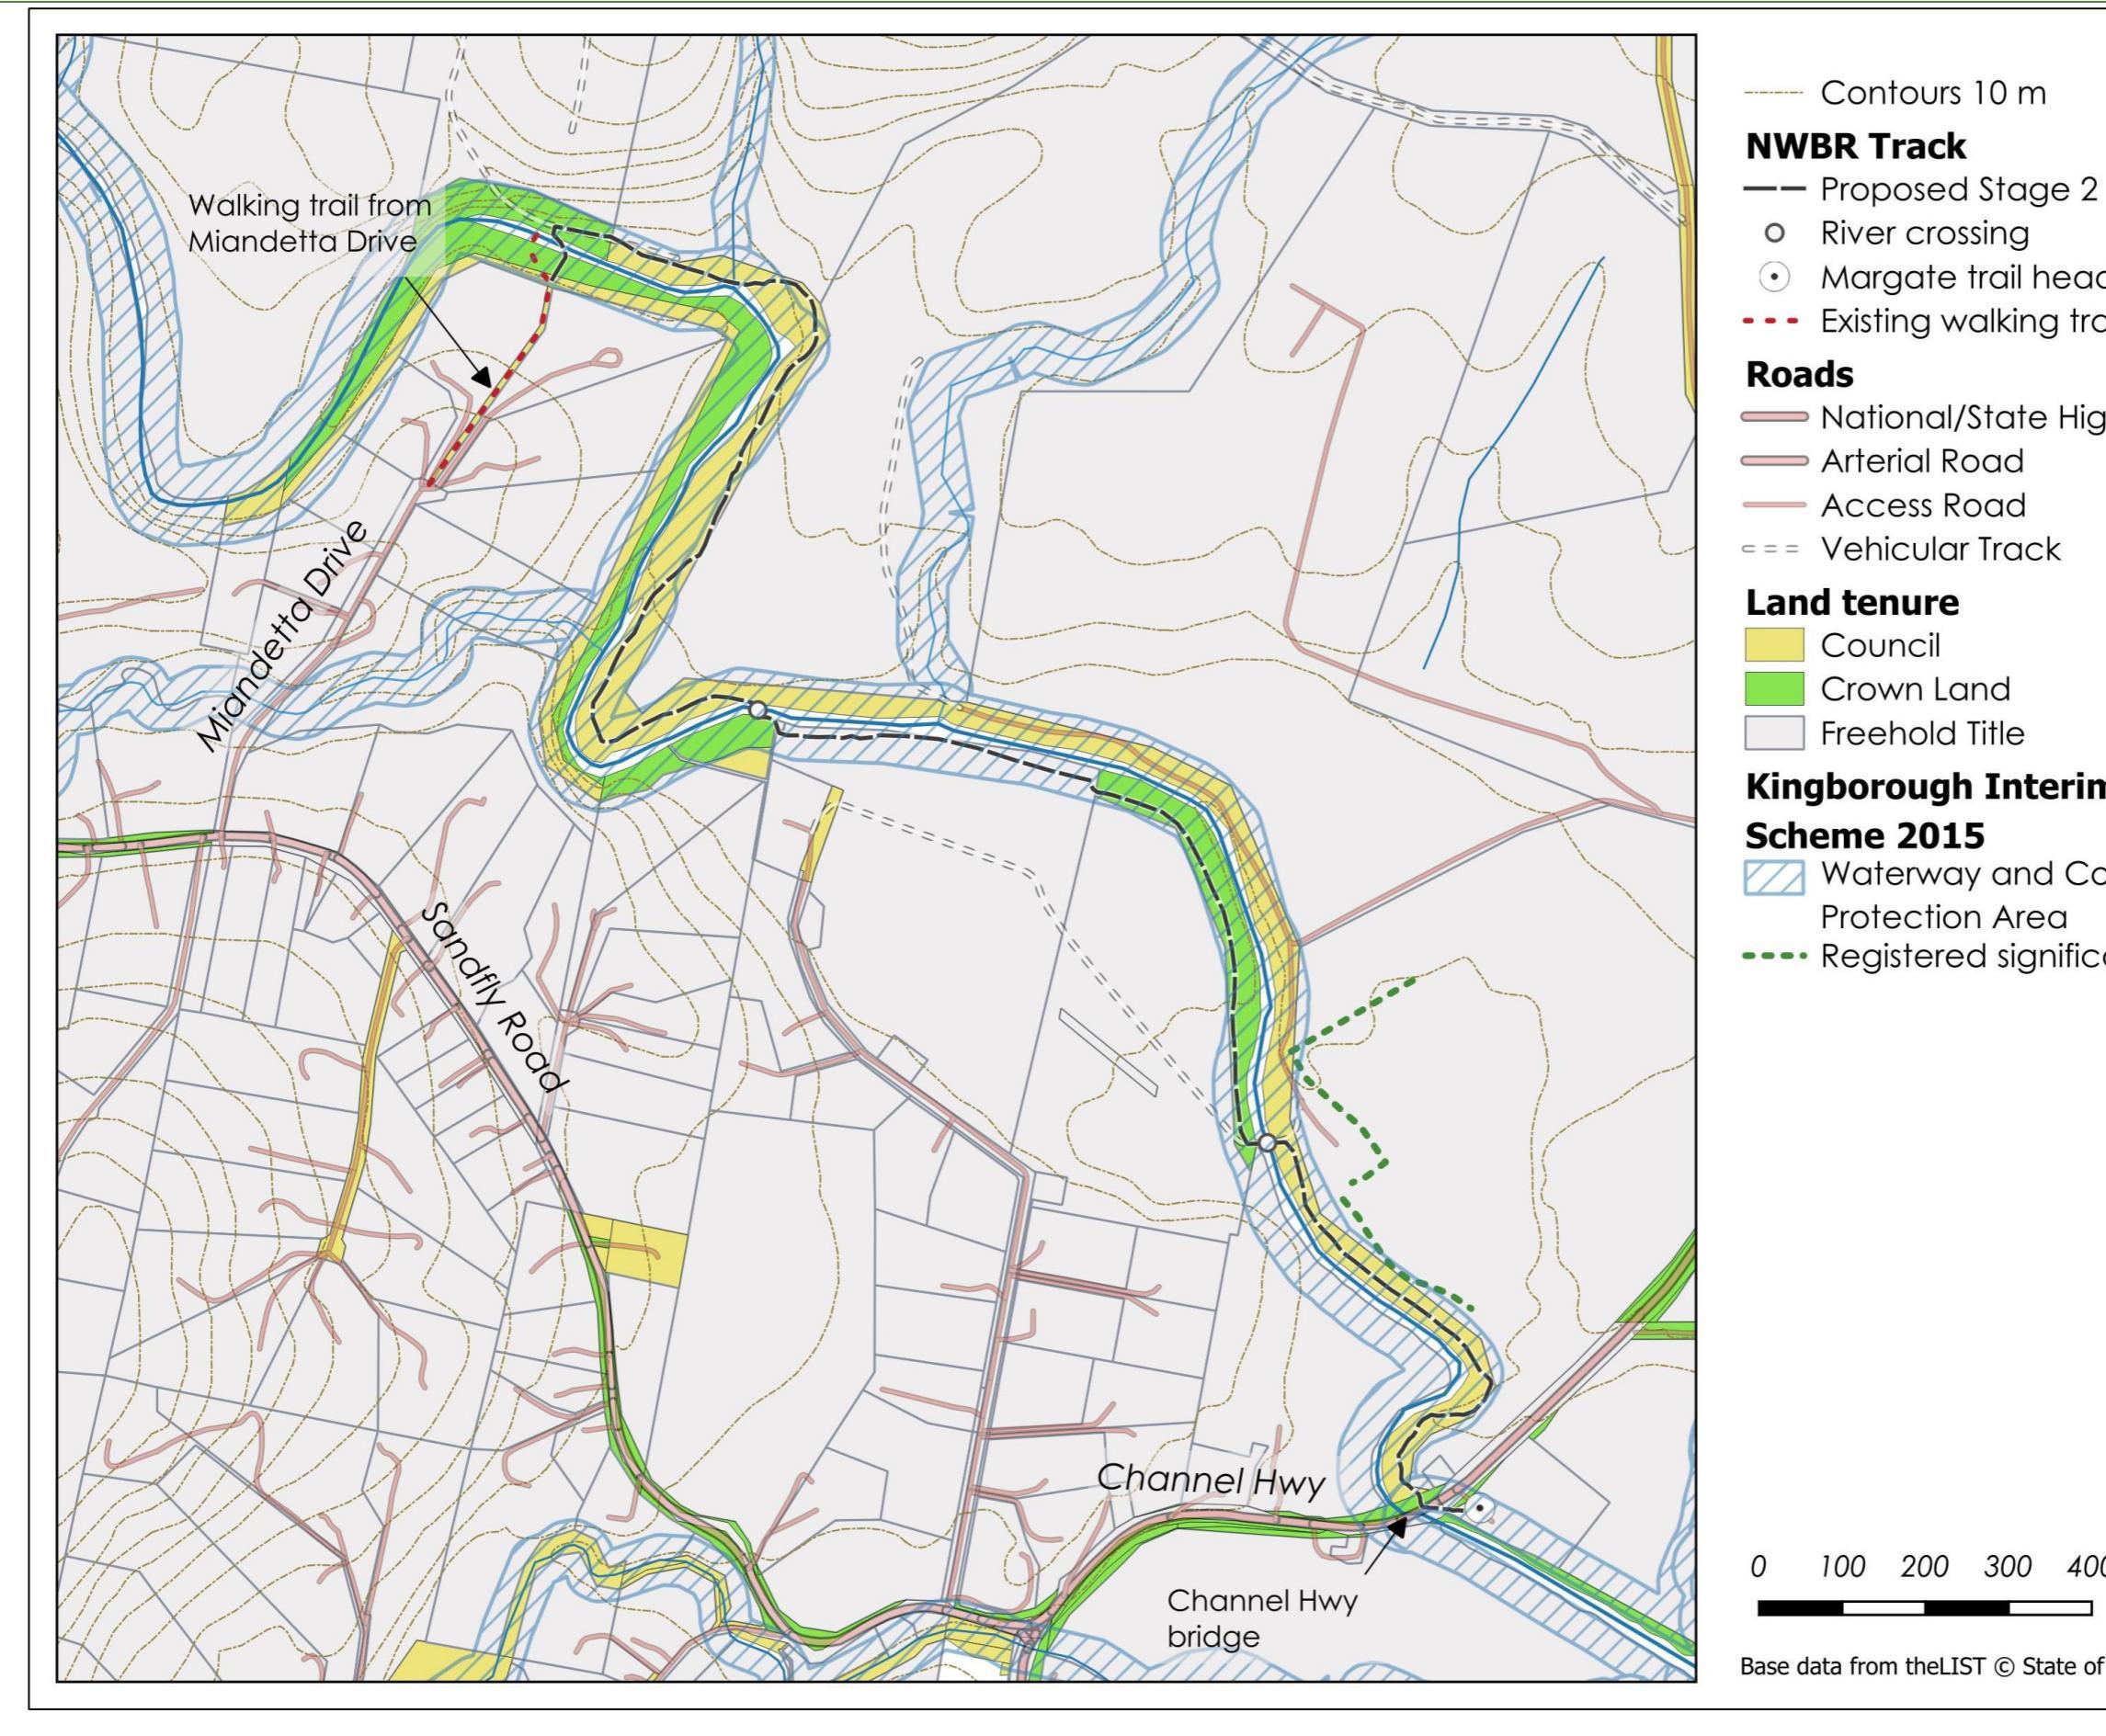
Figure 1. Land tenure and proposed trail route at Margate. KIPS Waterway and Coastal Protection Area shown, other overlays (including Biodiversity Protection Area) not shown for clarity.

Land tenure along this section is a mostly a mix of Crown Land and Council Reserve (Figure 1), zoned either Environmental Management or Environmental Living under the *Kingborough Interim Planning Scheme 2015* (Figure 2). Private land zoned Rural Resource on the Brookfield property accommodates 400 m of trail. The trailhead at Margate is in the Recreation zone and a short section under the Channel Highway is in the Utilities zone. Most of the proposed trail is within a Waterway and Coastal Protection Area and the entire project is covered by a Biodiversity Protection Area overlay.

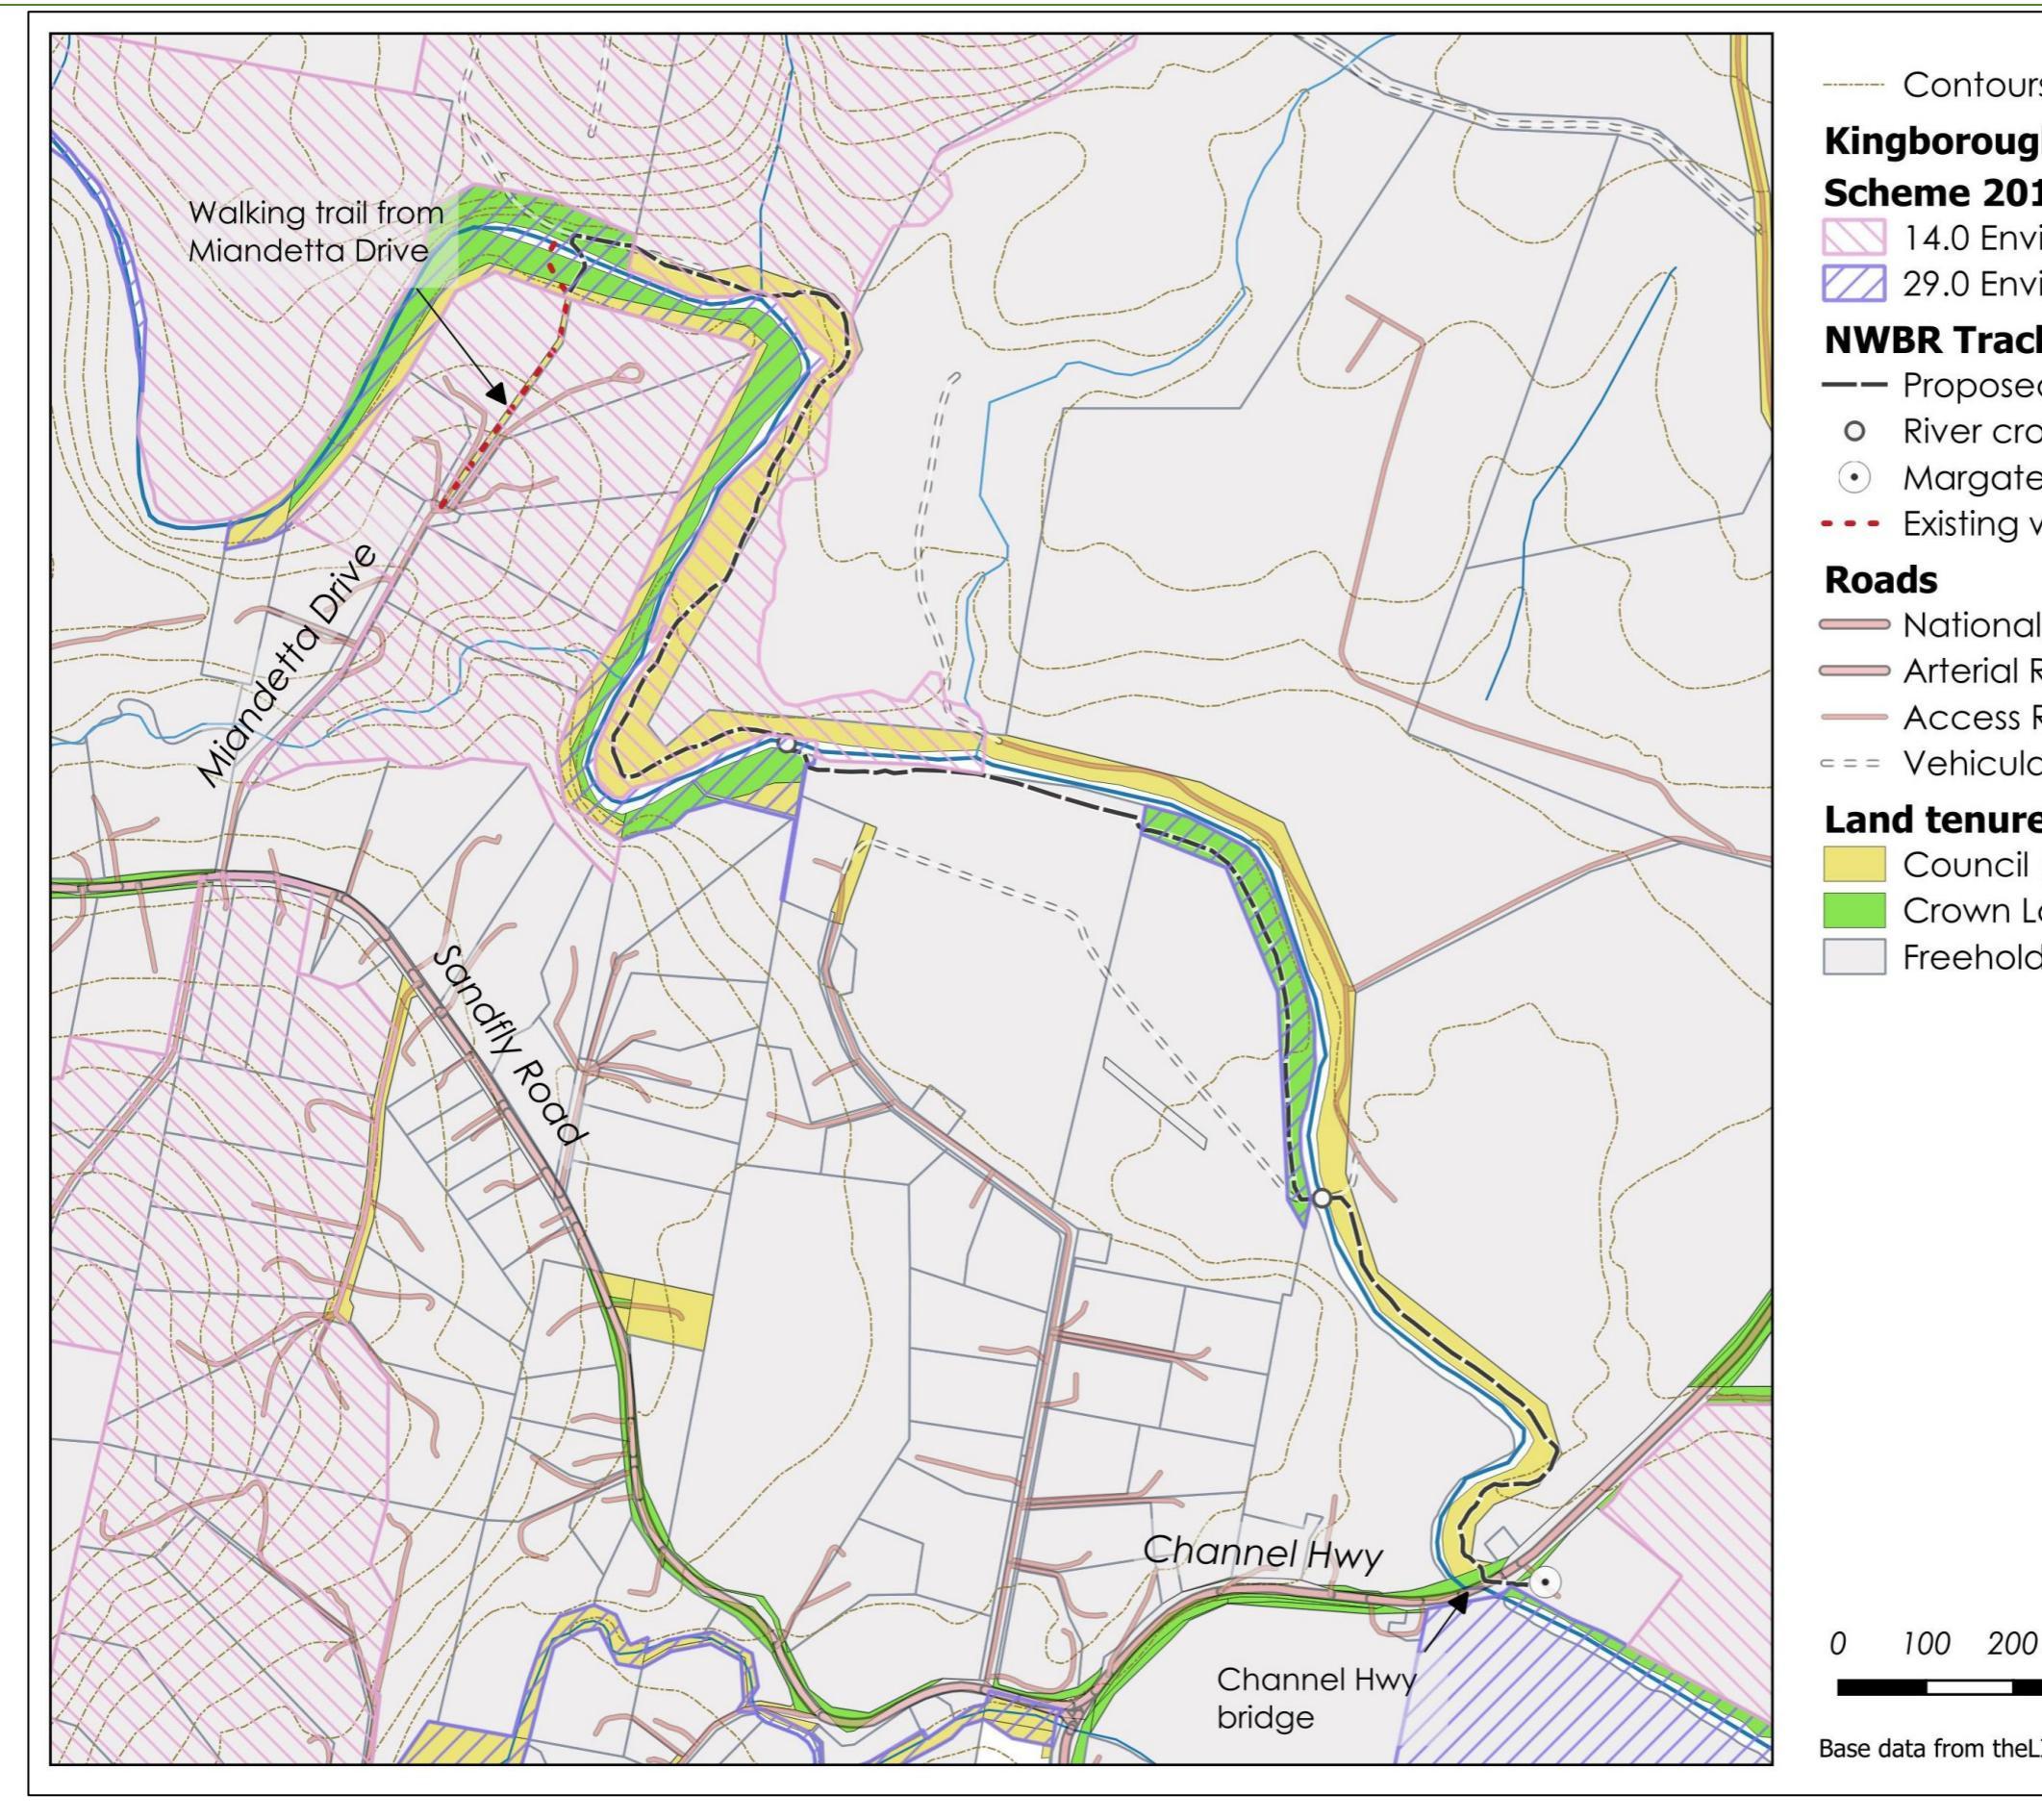
Figure 2. Location of Local Government and Crown Land reserves, shown with Environmental Living and Environmental Management Zones under the Kingborough Interim Planning Scheme 2015.

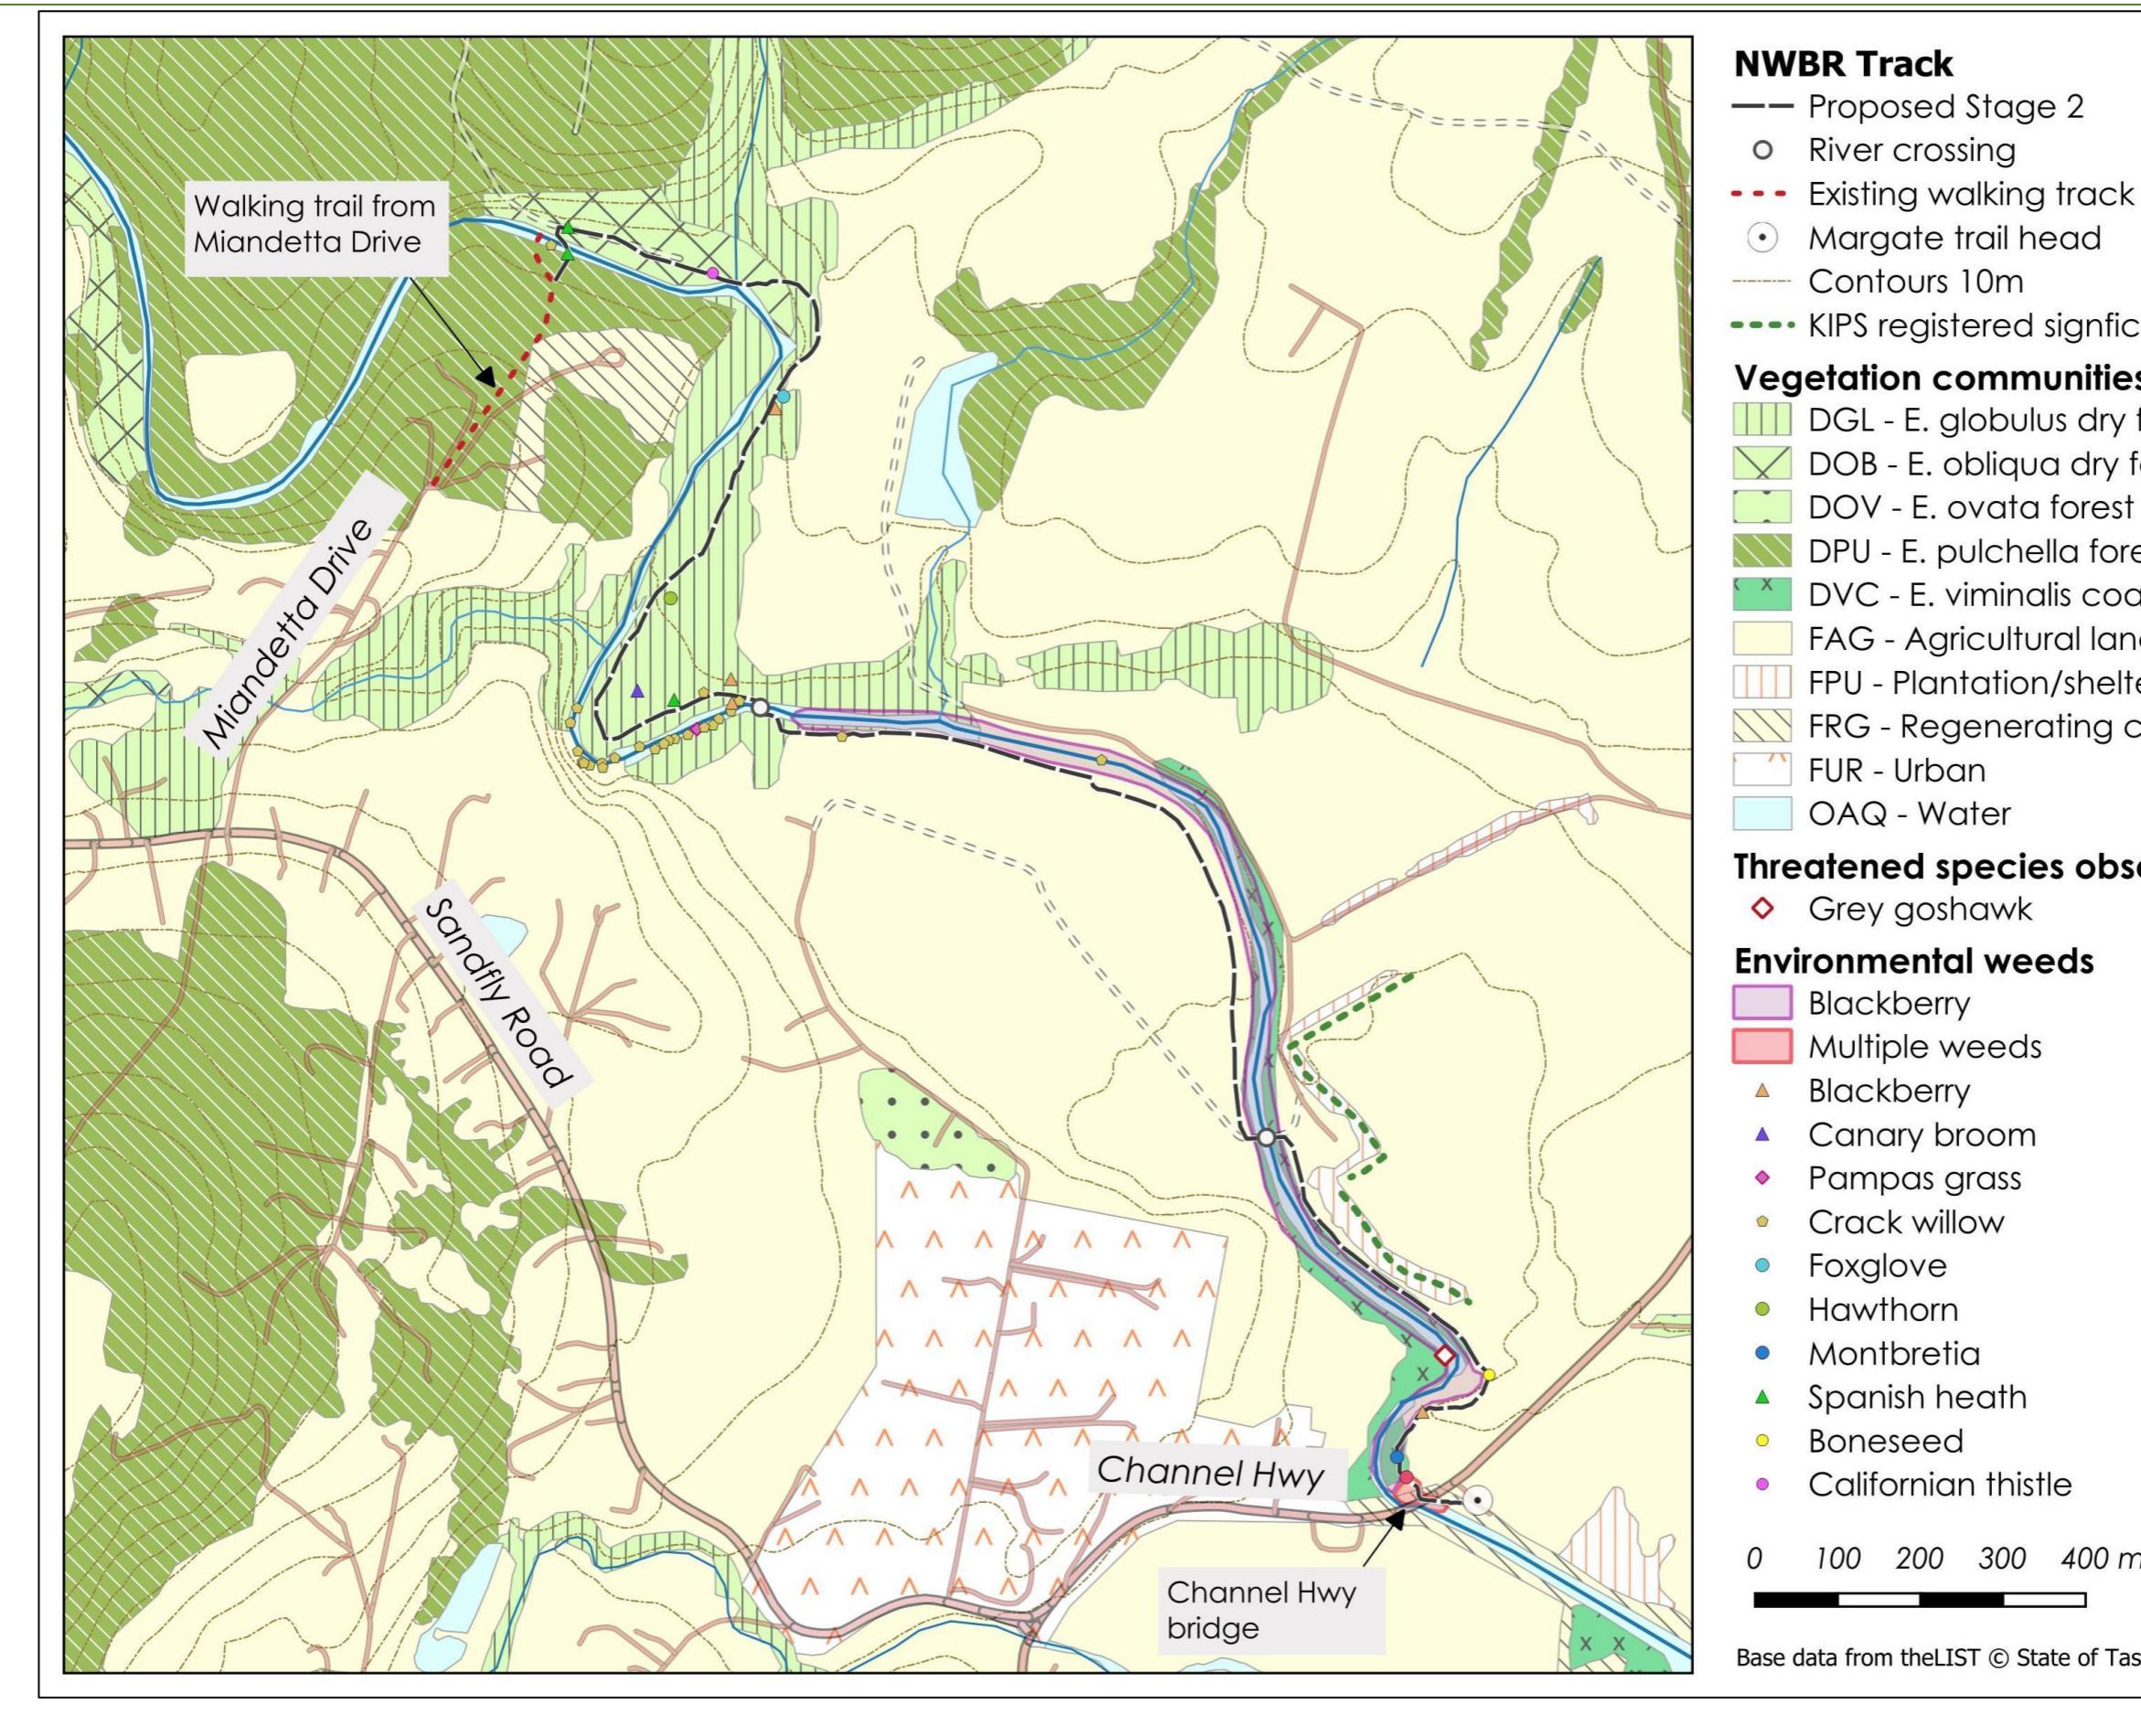
Figure 3. Vegetation communities and weeds mapped along trail route.

Four native vegetation communities and one modified vegetation type (cleared land) were mapped along the proposed trail route as per the TASVEG (v4.0) vegetation classification system (Figure 3). Vegetation mapping was restricted to the trail corridor (approximately 40 m wide).

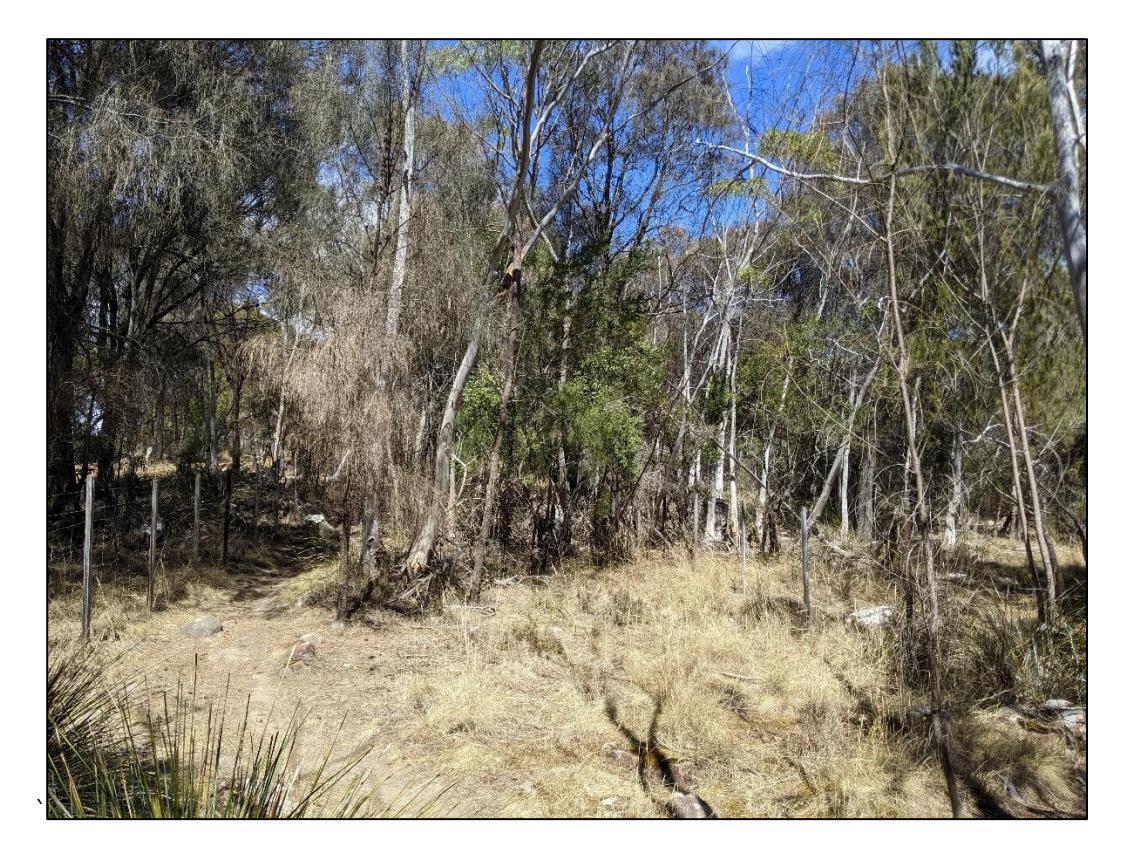
Photo 1. DPU forest with mix of dense shrubs and open grassy understorey. Miandetta Drive trail on LHS.

This forest dominated by white peppermint (*E. pulchella*) occurs on a dry north-facing dolerite slope. A tall shrub layer and featuring drooping sheoak (*Allocasuarina verticillata*), prickly box (*Bursaria spinosa*) and native cherry (*Exocarpos cupressiformis*) is well developed

on rocky sites (Photo 1). A diverse groundcover of sedges, sagg (*Lomandra longifolia*), grasses, herbs and prostrate shrubs occurs throughout most of this community. Native grasses and sedges are particularly abundant in more open situations where the shrub layer is sparse and on flat and seasonally damp sites, where black gum (*E. ovata*) is the major canopy tree. In contrast, the groundcover is sparse under dense sheoaks or on rocky ground.

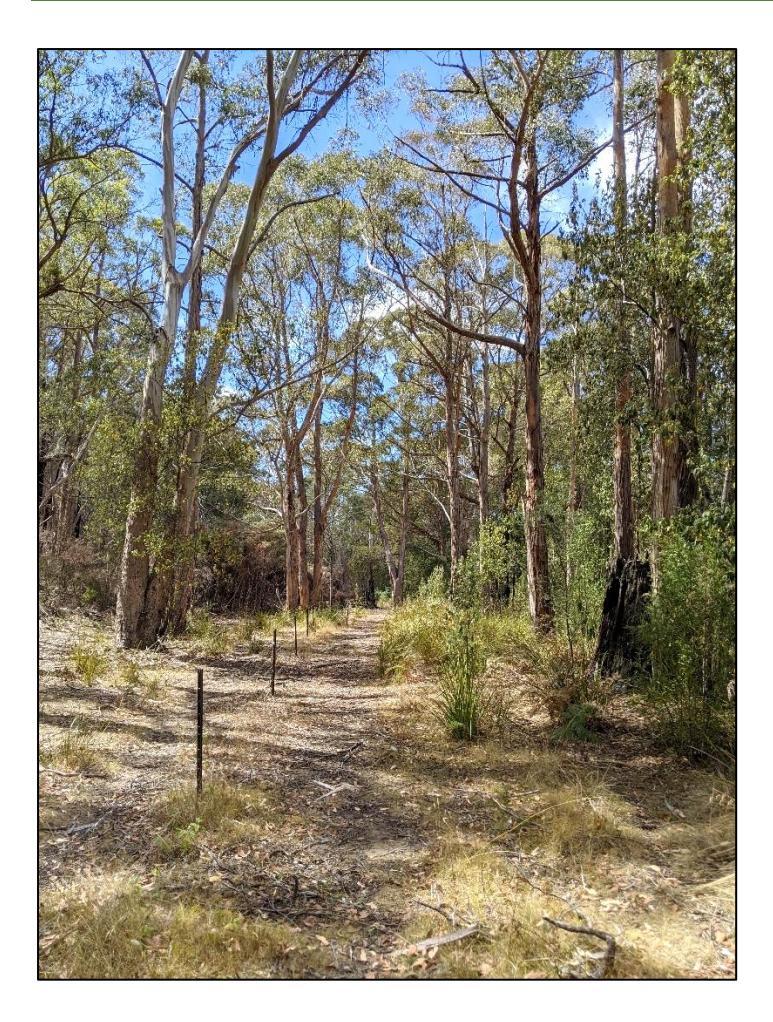
Photo 2. DOB forest on river flats on Crown Land. Proposed trail follows existing informal trail on RHS of fence.

The forest type has a canopy dominated by stringybark (*Eucalyptus obliqua*) and white gum (*E. viminalis*). The riverbanks and alluvial flats support a dense tall shrub layer dominated by dogwood (*Pomaderris apetala*), except where the understorey has been cleared along the vehicular track and fenceline (Photo 2). Grasses and sedges are prominent in the groundcover layer, often forming a dense sward. Like most of the stringybark forest along the lower reaches of the river, this forest is transitional between wet and dry *E. obliqua* communities, with structural and floristic components typical of both DOB and WOB.

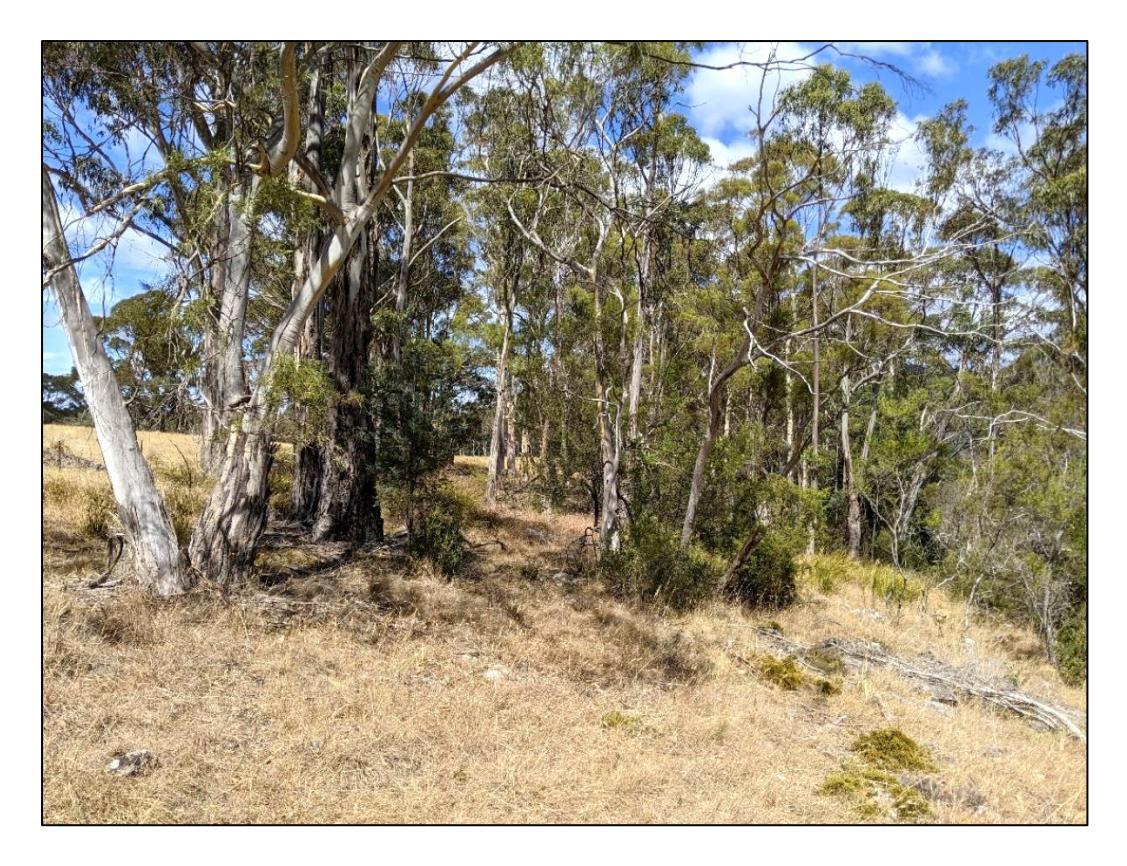
Photo 3. DGL forest with open grassy understorey on bank above river bend.

This forest is characterised by a canopy of blue gum (*E globulus*) and an understorey of dry forest shrubs and grasses. White gum occurs as a subdominant canopy species. Trees are multi-aged but old-growth trees are absent.

On higher ground where surface rock indicates shallow soils the forest is open with few trees and shrubs and a dense grassy groundcover of kangaroo grass (*Themeda triandra*) and other native grasses along with some exotic grasses (Photo 3). Scattered shrubs, such as prickly box, become more prominent on the lower slopes and steep riverbanks.

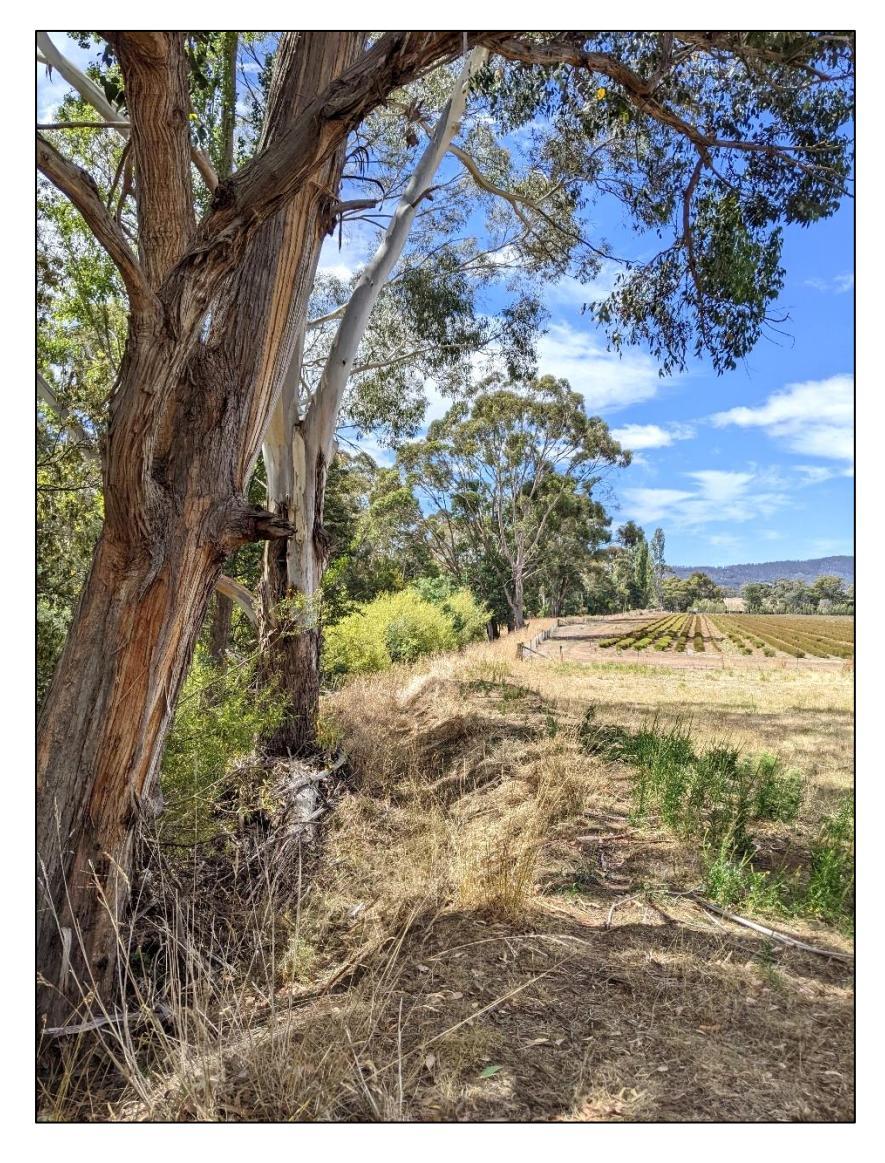
Photo 4. DVC forest along river (LHS) with agricultural land on alluvial flats. Proposed trail route in centre of photo, following levee bank and fenceline.

This forest dominated by white gum, with occasional stringybark trees, is restricted to a narrow riparian strip along the lower reaches of the river (Photo 4). It occupies the steep riverbanks between the river and the extensive alluvial flats, which are entirely cleared for agriculture. Mature eucalypt trees of significant size are present in this community. Smaller trees such as dogwood and silver wattle (*Acacia dealbata*) are common. Exotic species such as willows and blackberry are common and often dominate the understorey. Pasture grasses, particularly cocksfoot (*Dactylis glomerata*), are prominent at the top of the riverbank and on the adjacent flats.

While the tree strata are generally healthy and intact, the overall condition of this community is poor due to the extent of weed invasion in the understorey and the narrow remnant landscape context.

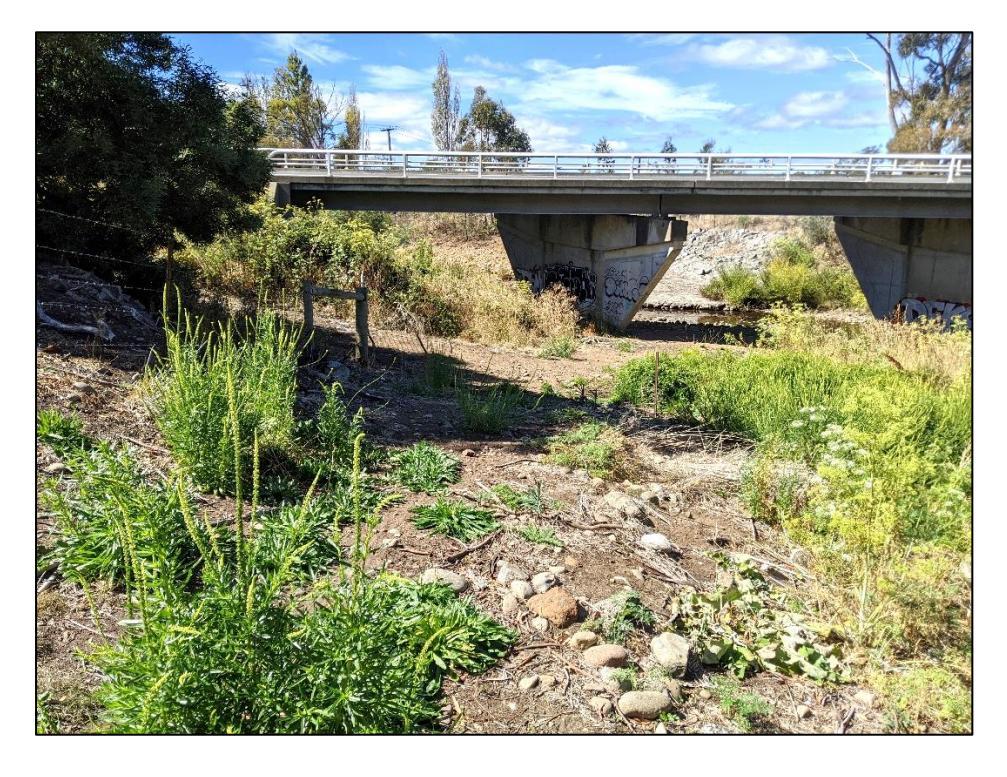
Photo 5. Disturbed area with numerous weed species in riparian zone near Channel Highway. Proposed trail route in centre of photograph, continuing under the highway bridge to Margate trailhead.

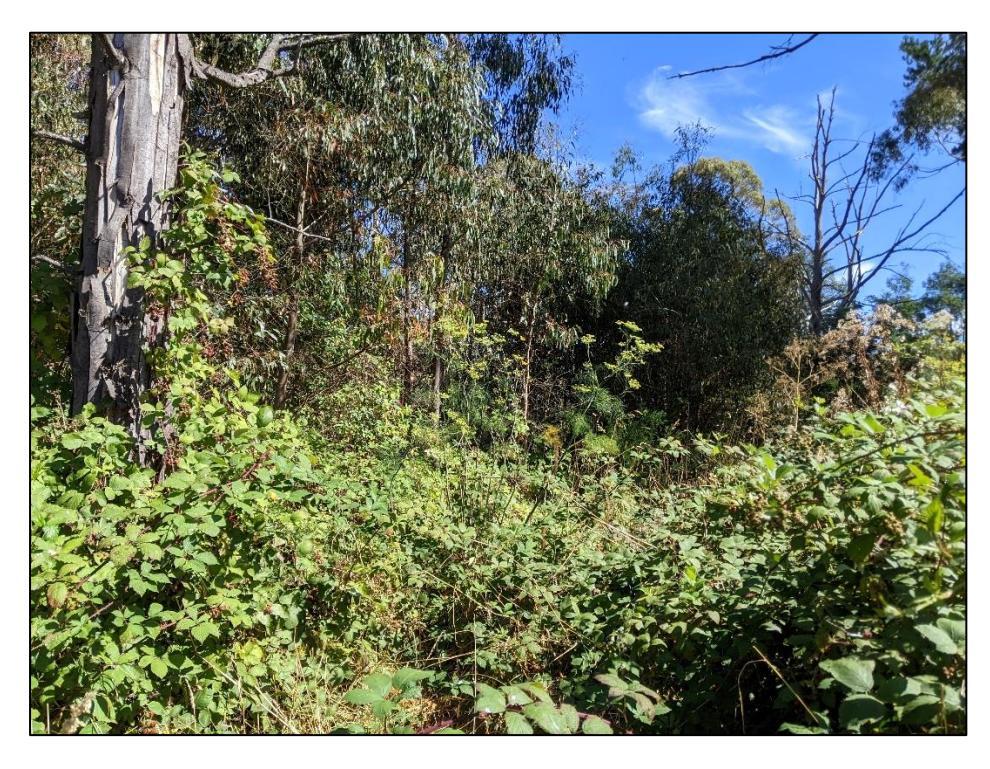
Photo 6. Dense blackberry dominating understorey of regrowth DVC forest on river flats near Channel Highway.

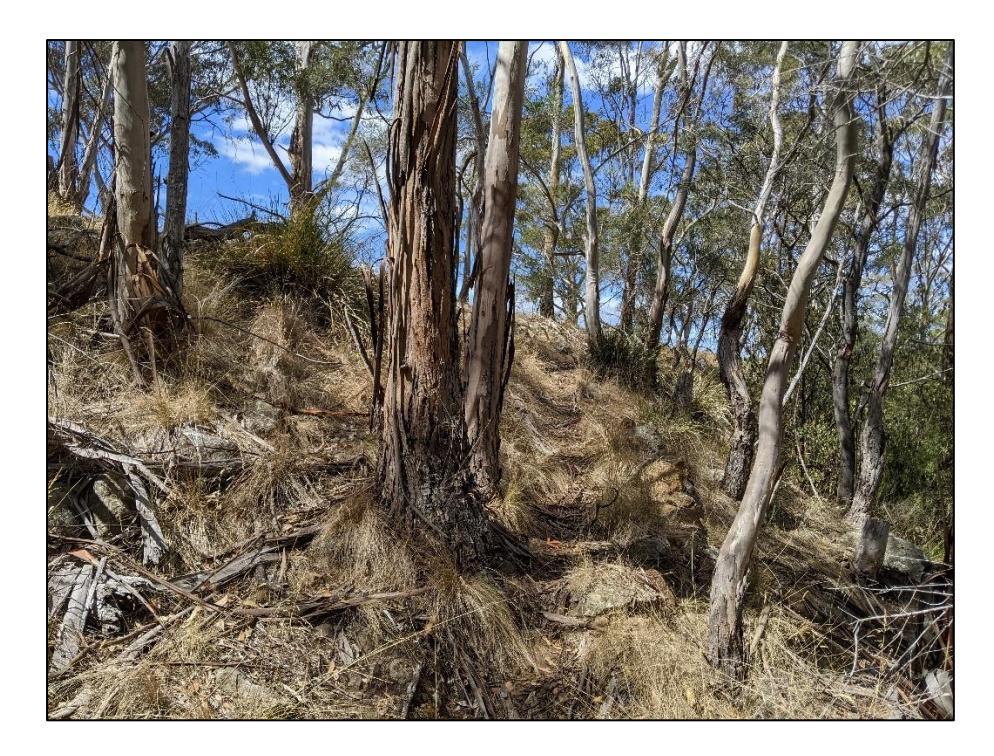
Photo 7. Steep bank in DGL forest. Trail construction in this section will require earthworks and vegetation clearing.

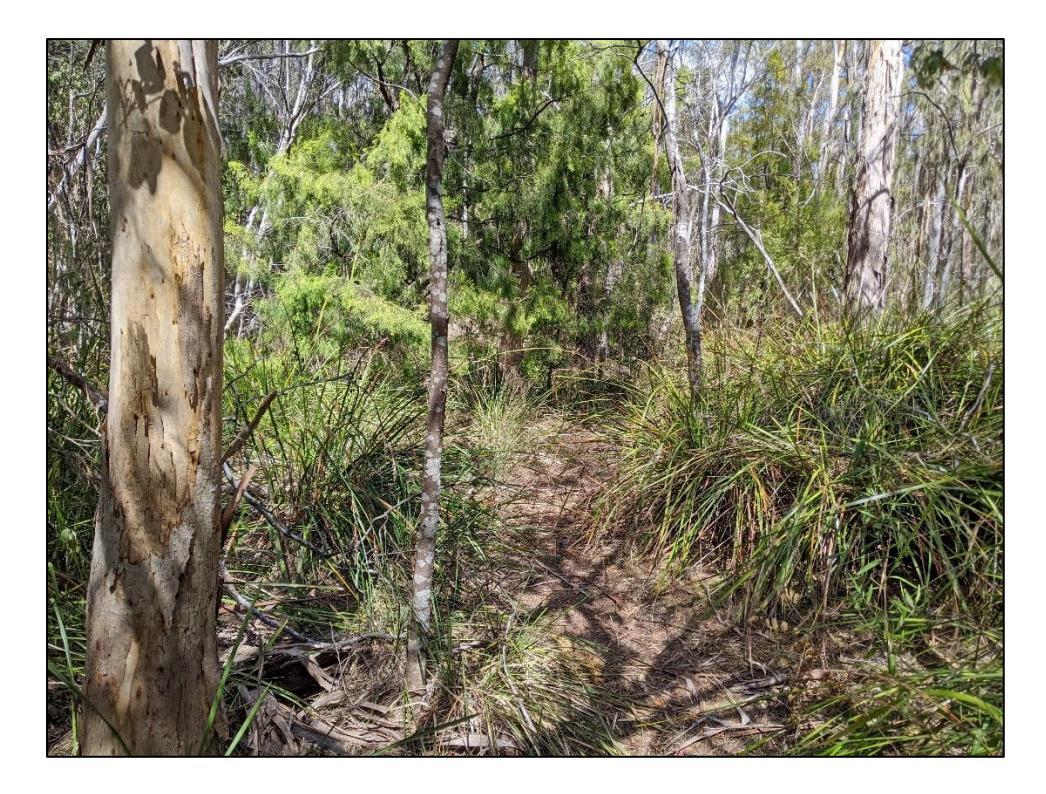
Photo 9. Dense understorey and existing Miandetta Road trail in riparian DPU forest.

The existing walking trail from the end of Miandetta Drive to the River on Council Land will require minor improvement works such as widening or removal of rocks to make the trail compliant with standards. No major erosion or drainage issues are apparent in this area. Utilising the existing trail alignment will minimise vegetation clearing. Approximately 30 m of new trail on Crown Land will be constructed to connect the northern end of the existing trail to the river crossing. The riparian forest in this area has a dense understorey of shrubs and sedges and so will require clearing of the trail footprint (Photo 9).
