GEO-ENVIRONMENTAL
SOLUTIONS

LANDSLIDE RISK ASSESSMENT

72 Sproules Road, Snug TAS 7054

May 2022

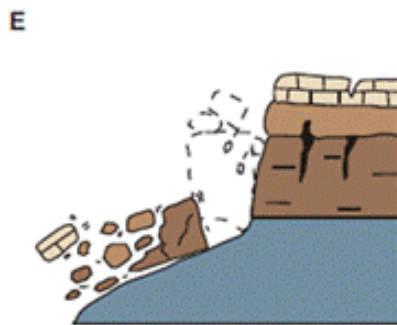
Topple

Figure B1 gives schematics to illustrate the major types of landslide movement. Further information and photographs of landslides are available on the USGS website at <http://landslides.usgs.gov>.

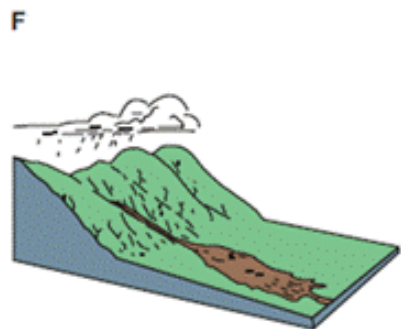
Debris flow
